Safety Information Notice

SUBJECT: MAIN ROTOR

Main Rotor Head - Rupture of the Hub

AIRCRAFT CONCERNED	Version(s)	
	Civil	Military
EC120	B

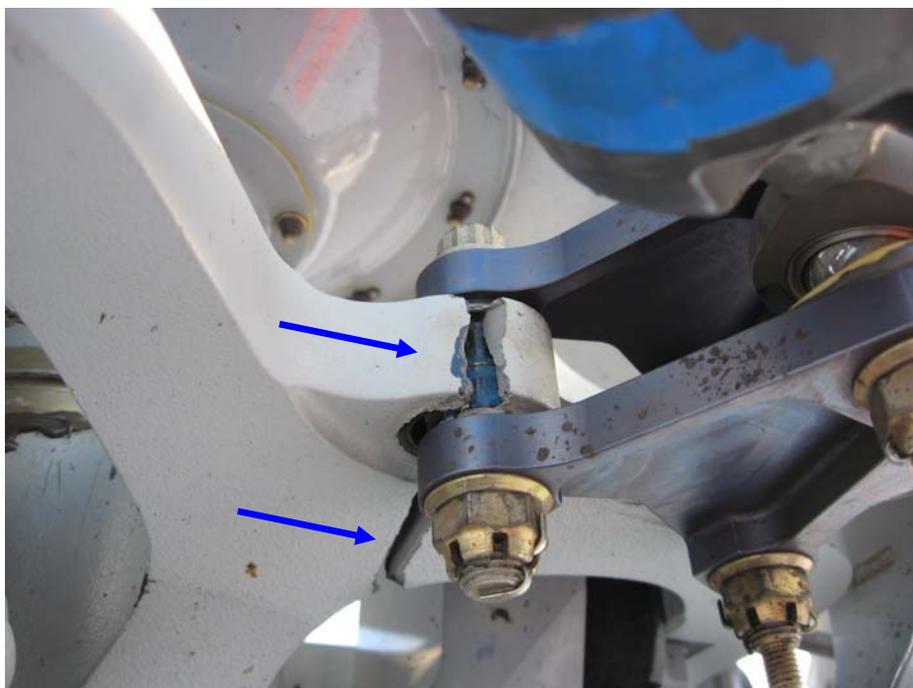
Figure 1

On the ground, the main rotor hub was found ruptured at a drag damper attachment hole (See Figure 1).

- During the Flight-Related Inspection (VLV), (These Flight-Related Checks of the day have to be conducted either after completion of a flying day or before starting a new flying day):
 - Check that the rotor hub is in serviceable condition and free from cracks (in the drag damper attachment area) as per AMM 05-30-00,6-1 Zone 2.
