R66 SERVICE BULLETIN SB-21

SUBJECT: Oil Tank Outlet Modification

ROTORCRAFT AFFECTED: R66 Helicopters S/N 0003 thru 0268. Spare G689-1 revision H and prior oil tank assemblies are also affected.

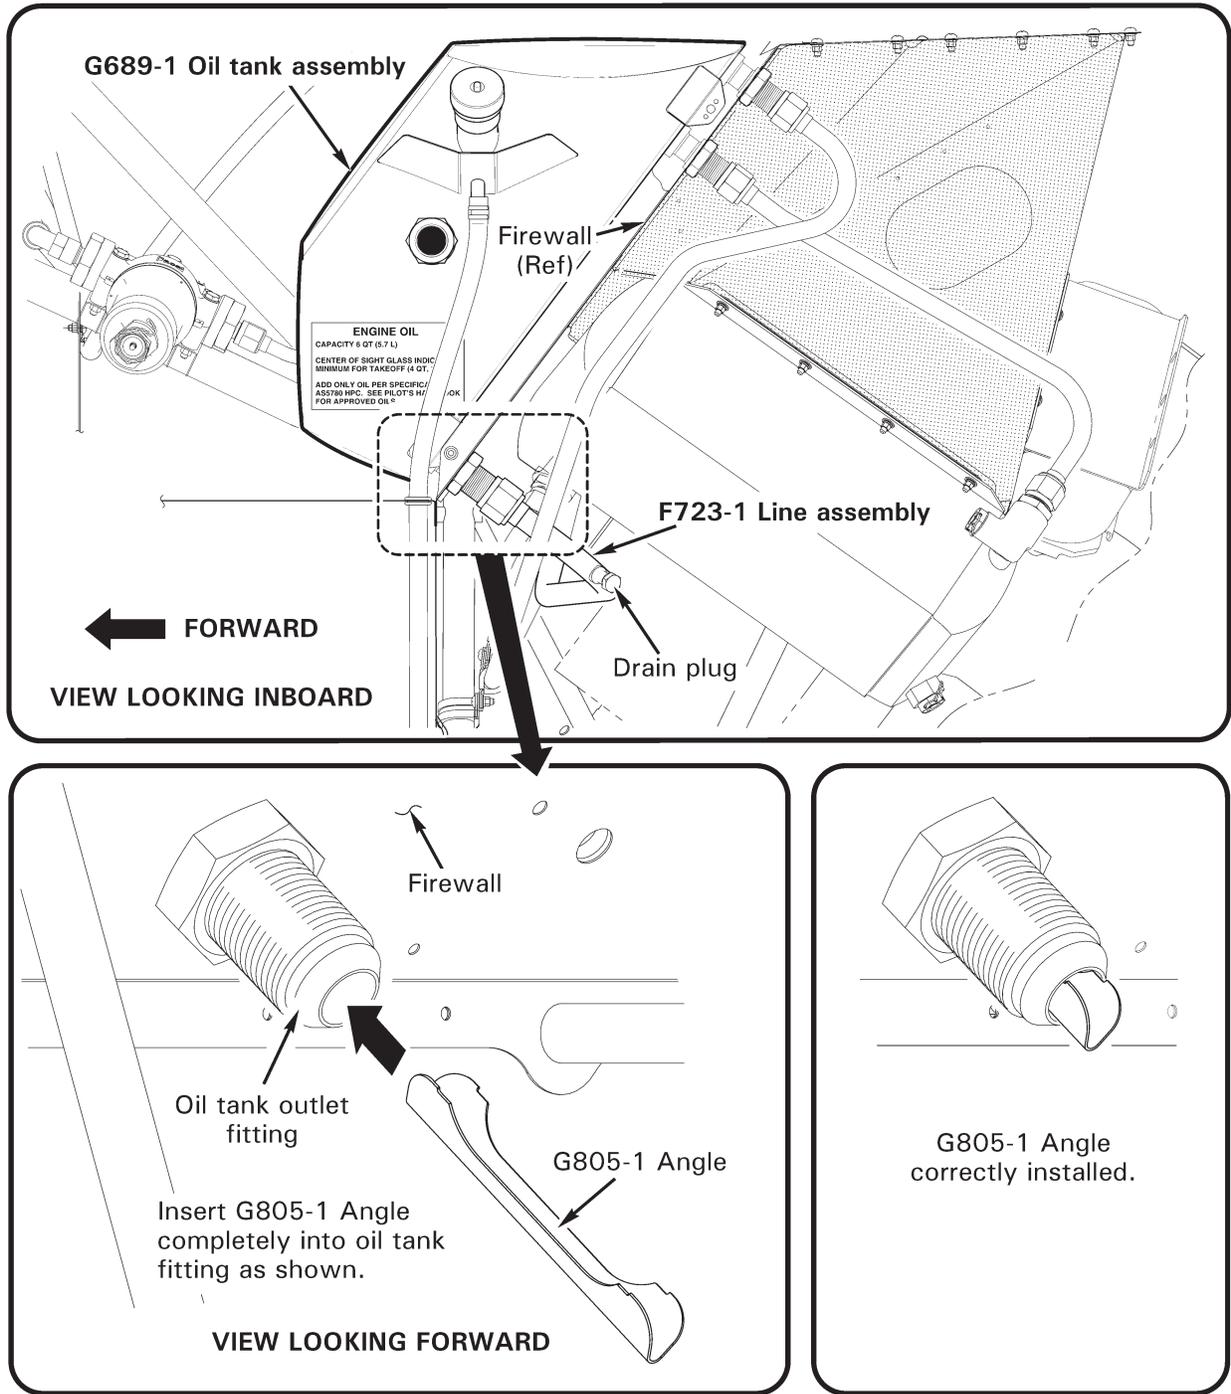
FIGURE 1

BACKGROUND: RHC has received a report of an oil tank internal baffle breaking loose and blocking the tank outlet. G689-1 revision H and prior oil tank assemblies were manufactured using a heat treat process which may have cracked the baffle welds. This bulletin requires installing an angle in the tank outlet that would prevent a failed baffle from blocking the outlet.

2. Drain engine oil per R66 Maintenance Manual (MM) § 12-60, utilizing suitable clean container if reusing oil.
3. Refer to Figure 1. Disconnect F723-1 line assembly from tank fitting at firewall.

4. Insert G805-1 angle (orientation optional) in oil tank outlet fitting until angle snaps in place. Pinch flanges of angle minimum required to enable insertion.

5. Connect F723-1 line assembly to tank fitting. Special torque nut to 675 in.-lb. Torque stripe fitting per MM Figure 5-1.
6. Add engine oil per MM § 12-60.
