APPENDIX A: MAIN ROTOR BLADE FAILURE ANALYSIS REPORT

ENGINEERED SYSTEM FAILURE ANALYSIS REPORT

MAIN ROTOR BLADE FRACTURE ROBINSON R22, VH-OHA OCCURRENCE 200302820

2 November 2005

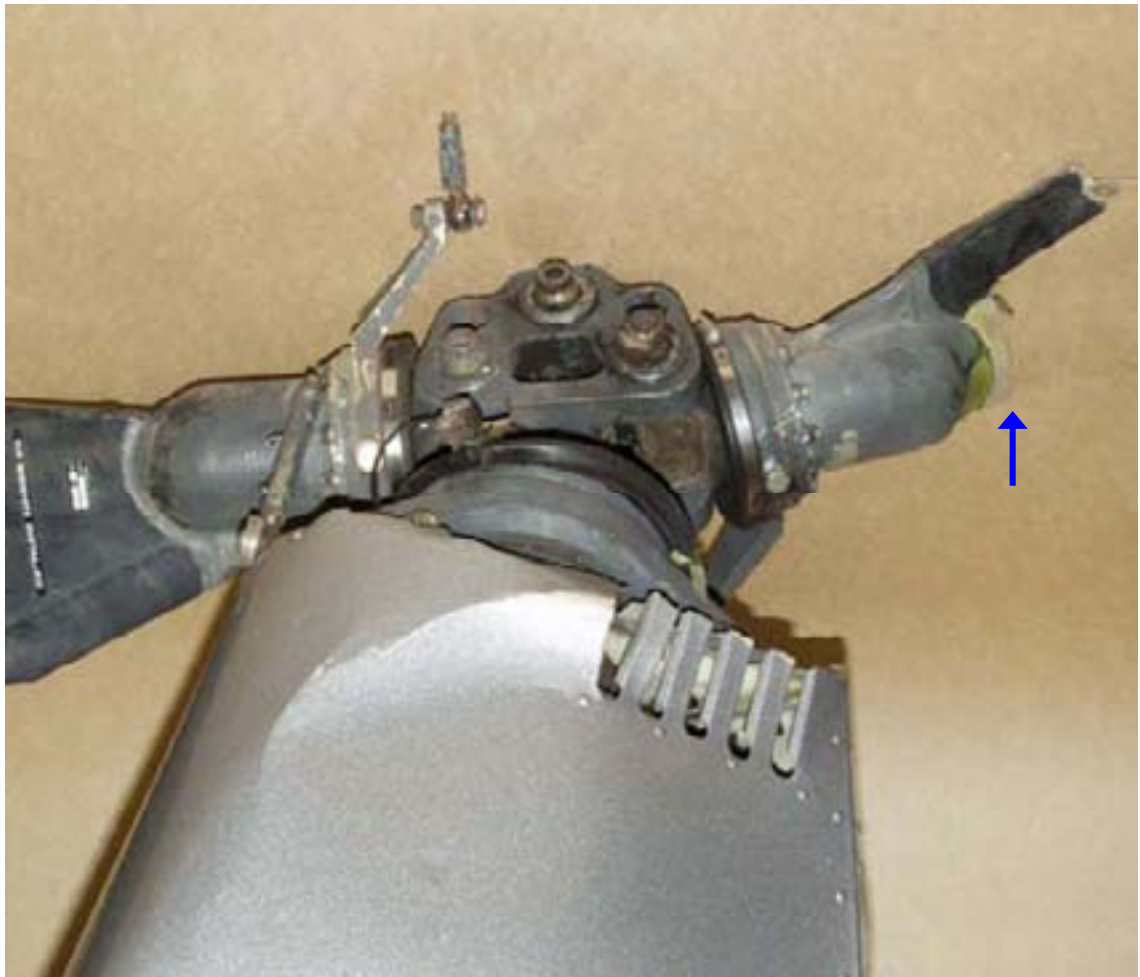
Figure 1: The recovered main rotor head assembly, VH-OHA

The root fitting of the blade, an aluminium alloy forging that accommodates the blade spindle and bearings, had fractured at the innermost bolthole of the root fitting to blade spar joint, see figures 1 and 2.

The fracture location (arrowed) is located at rotor station (RS) 10.35, the location of the inboard bolthole in the fitting to spar joint.

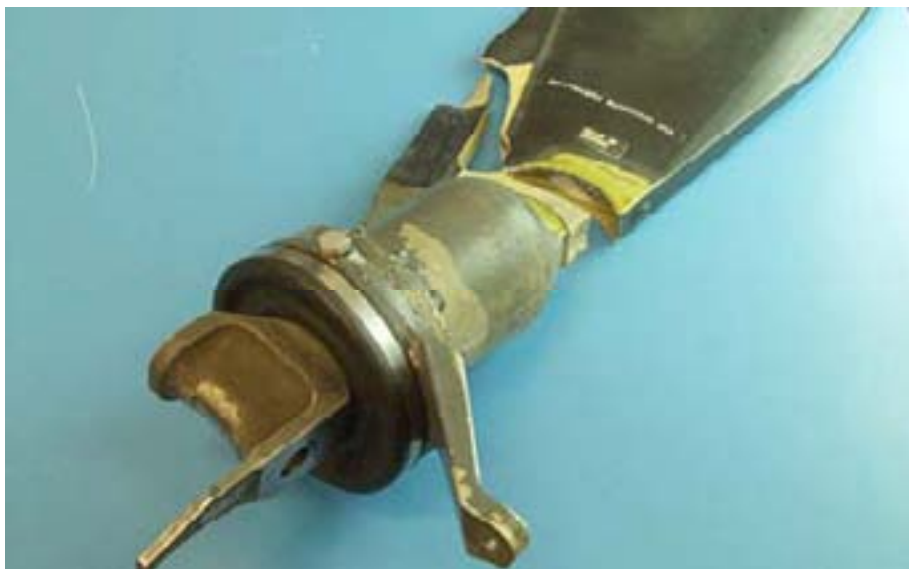
Figure 2: The fractured main rotor blade, VH-OHA

The lower surface of the main rotor blade (painted black) is shown in this figure. The upper surface of the blade is painted white.

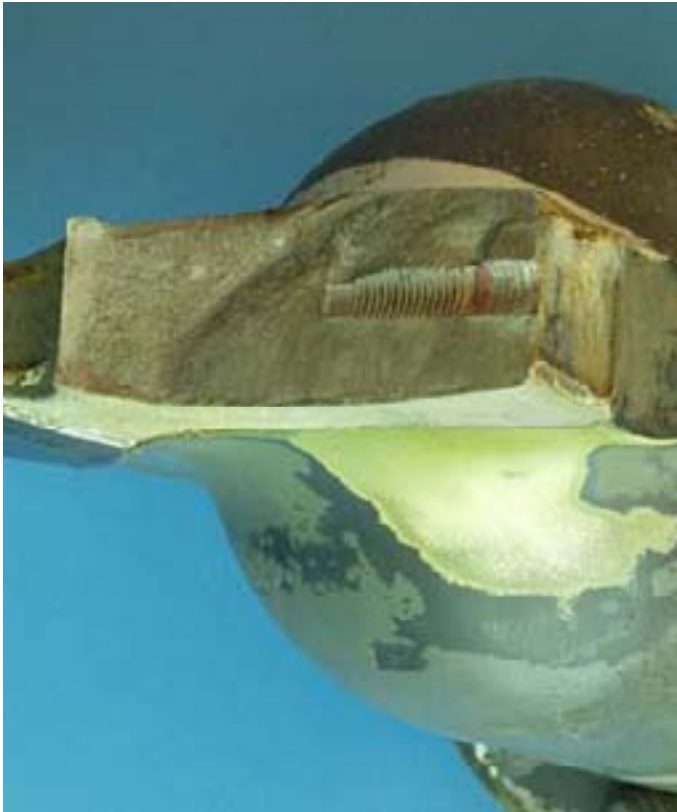
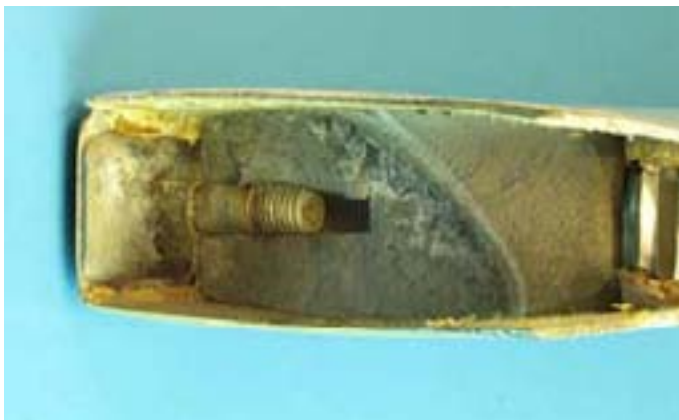
Figure 4: Fracture features, blade s/n 6249A – as recovered

The fracture surface features indicate that fracture occurred as a result of the progressive growth of a crack from the inboard bolthole. The mechanism of crack growth was established to be fatigue, that is, crack initiation and progressive crack extension in response to the development of a number of repeated localised alternating stresses during operation. The features of the fracture are shown in figures 4 and 5.

a) The fitting side, or inboard side, of the fracture

b) The blade side, or outboard side, of the fracture

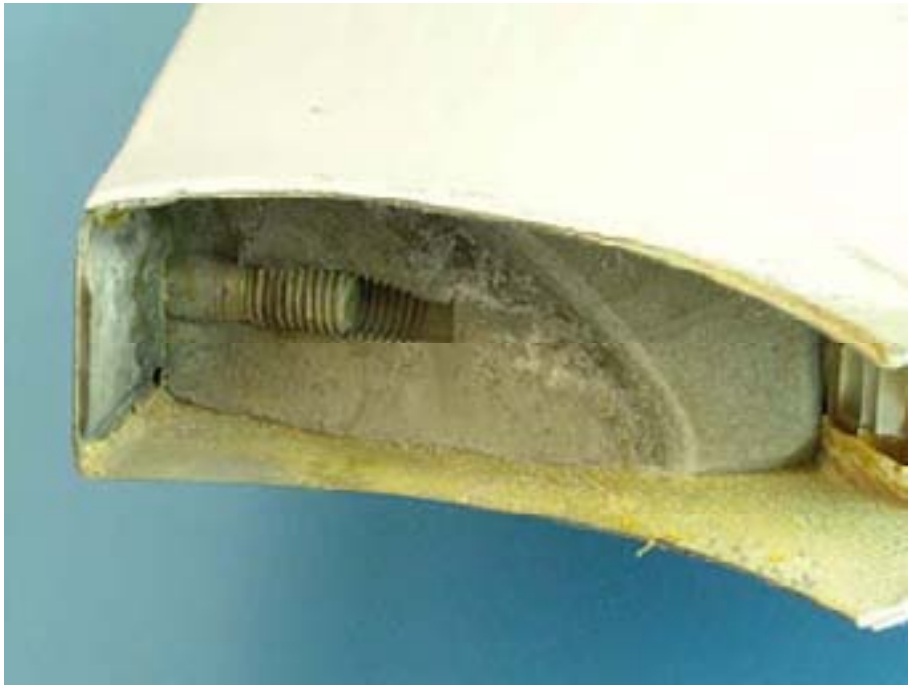
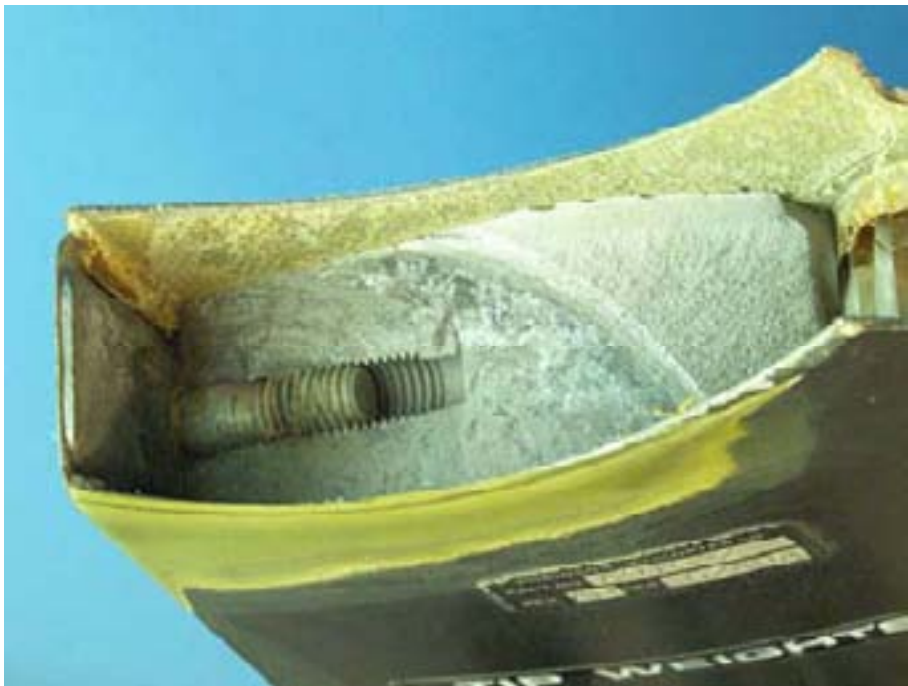
Figure 5: Detailed views of the blade side of the fracture, as received

a) Looking down from the upper surface of the blade

b) Looking up from the lower surface of the blade

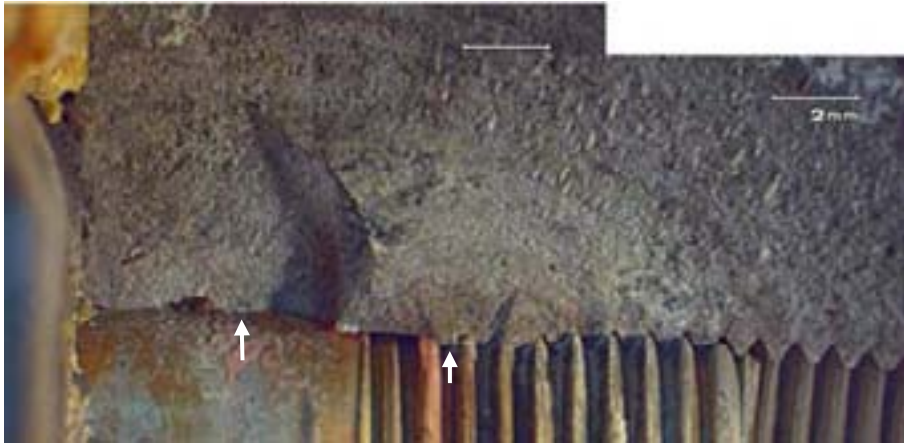
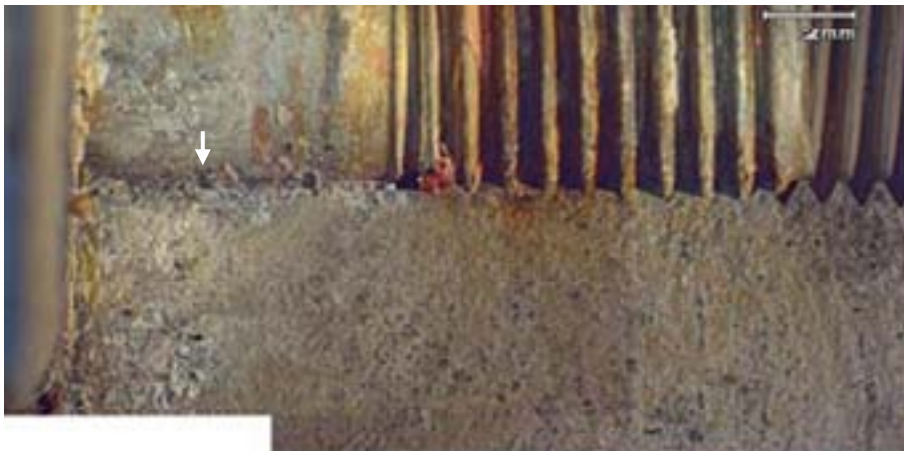
Figure 6: The sites of fatigue crack initiation, blade s/n 6249A

Fatigue cracking initiated at three sites within the bolthole. All three sites lay in a plane normal to the blade spanwise axis, see figures 6 and 7. One site was located on the lower side of the bolthole counterbore region. The remaining two initiation sites

a) Upper side of the bolthole with the bolt in situ. The sites of fatigue crack initiation are arrowed

b) Lower side of the bolthole with the bolt in situ. The site of fatigue crack initiation is arrowed

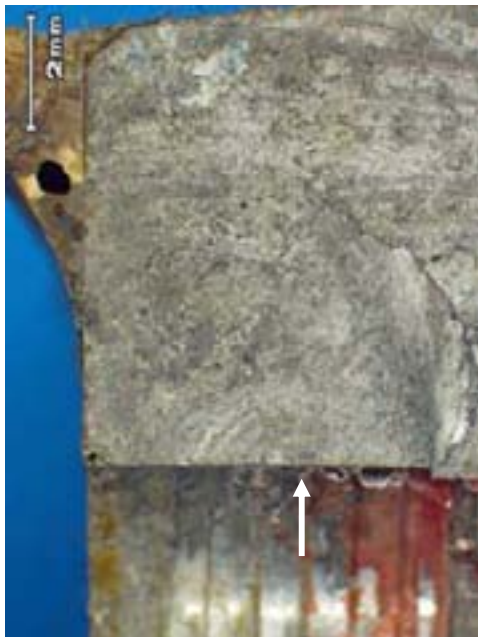
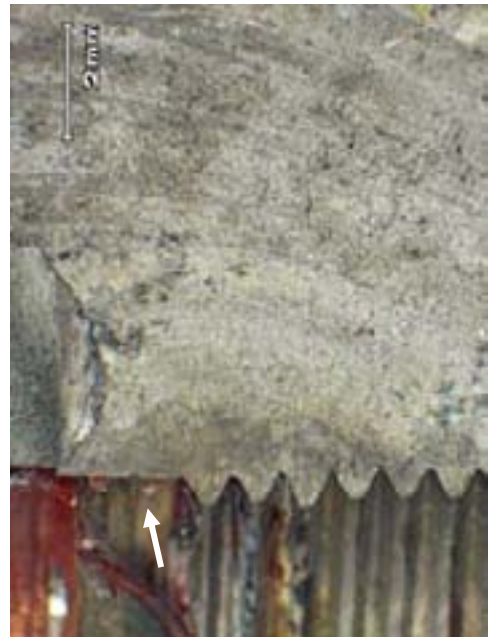
Figure 7: Detailed views of the fatigue crack initiation sites following removal of the bolt and cleaning of the fracture surface

The nature of crack progression markings indicate that fatigue crack initiation occurred first at the lower side of the bolthole, secondly at the thread on the upper side of the bolthole and thirdly at the counterbore on the upper side of the bolthole.

a) Third initiation site, crack growth from this site was influenced by the presence of the crack growing from second initiation site

b) Second initiation site

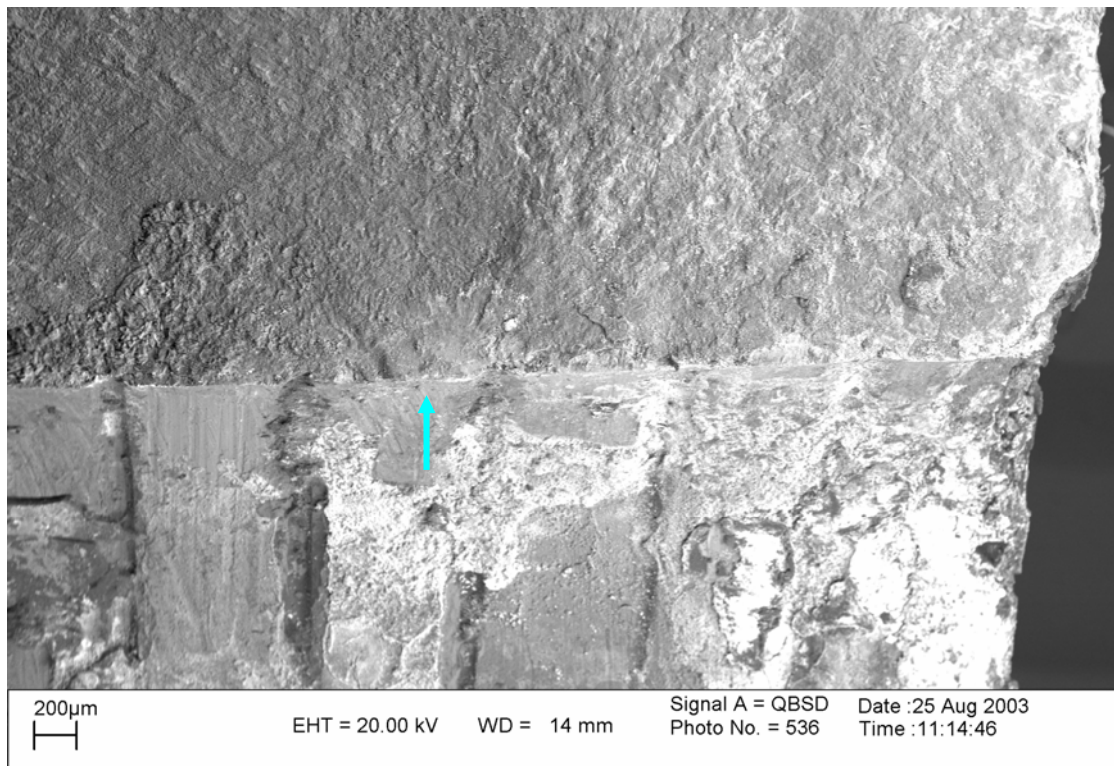
Figure 8: Scanning electron micrograph of the first initiation site

It is evident that moisture had penetrated the fatigue crack and reacted with the crack surfaces. Following removal of the bolt it was evident that localised corrosion had occurred in the counterbore, see figures 8 and 9.

Fatigue crack initiation was associated with localised corrosion. It was not associated with the remnant of the thread.

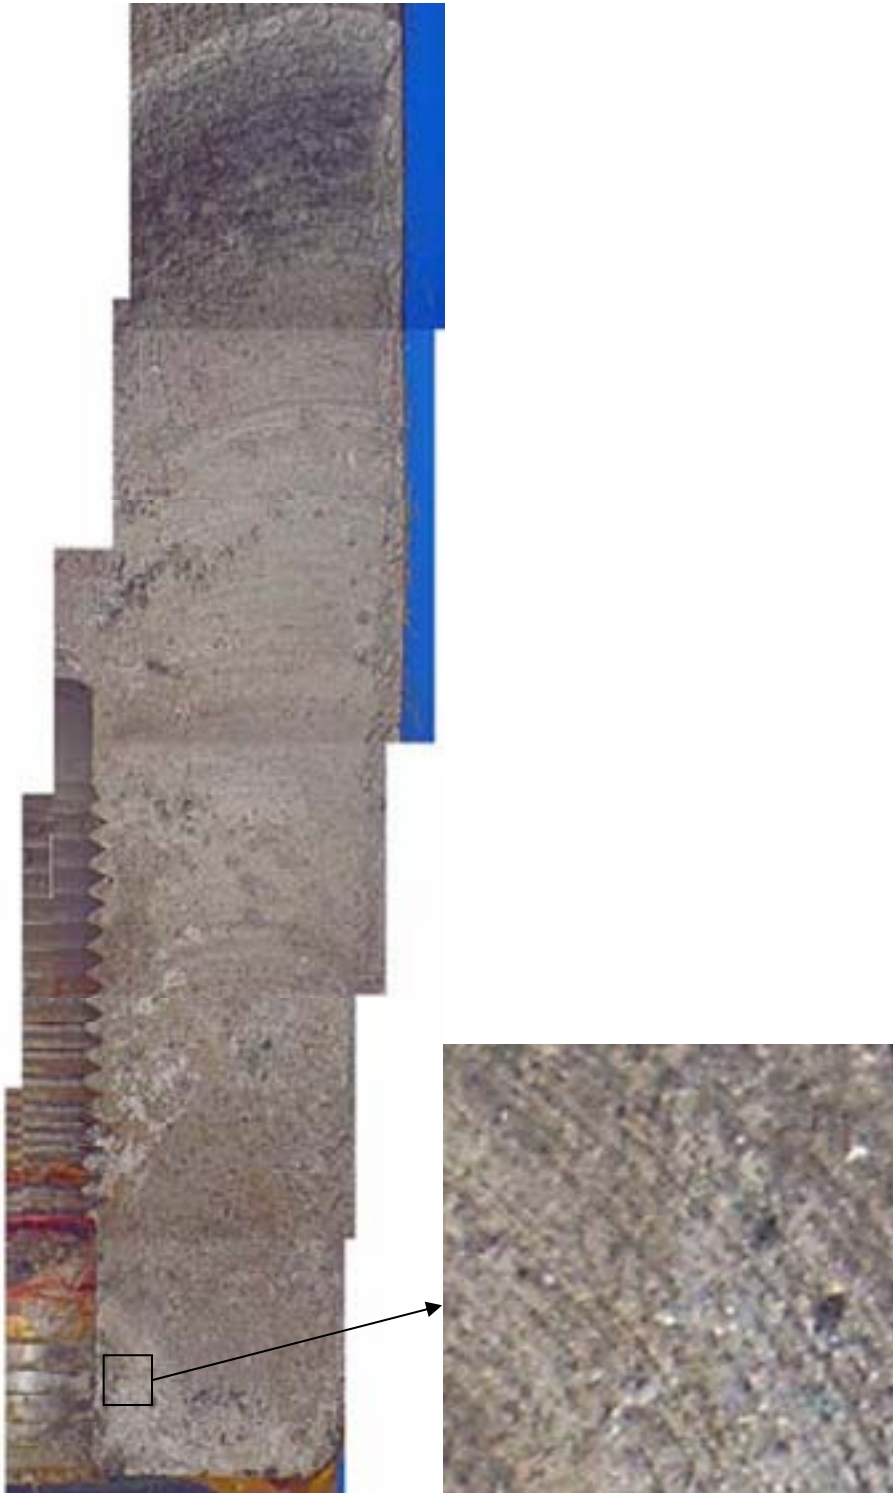
Figure 10: Photomontage of the fatigue fracture (lower half)

A key feature of the fatigue crack progression markings is the visually apparent banding. These bands can be seen in the photomontage of the fracture, see figure 10.

Fatigue crack progression mark bands indicate that crack growth has occurred as a result of the repeated application of blocks of variable amplitude loads. For the case of aircraft operation, blocks of variable amplitude loads are associated with each flight cycle. One major loading cycle is associated with the generation of lift forces during flight. Superimposed on this load cycle are other loading cycles associated with manoeuvres and the operation of mechanisms. For a helicopter main rotor, the major load cycle is developed with the start of blade rotation, through takeoff and flight, to the stoppage of blade rotation. Inflight alternating loads on the main rotor are developed through manoeuvres and the alternating drag forces on the blades as the blades advance and retreat with each rotation of the rotor during flight.

Although the fine features of the fatigue fracture surface had been masked by the products of the reaction of water and the aluminium alloy fitting, at least 150 bands could be discerned over the length of crack progression. On the basis that each band is likely to be a result of a flight cycle, it appears that crack growth has occurred over a period of at least 150 flights. An estimation of the time of crack growth would require a detailed knowledge of the duration of each flight or major load cycle.

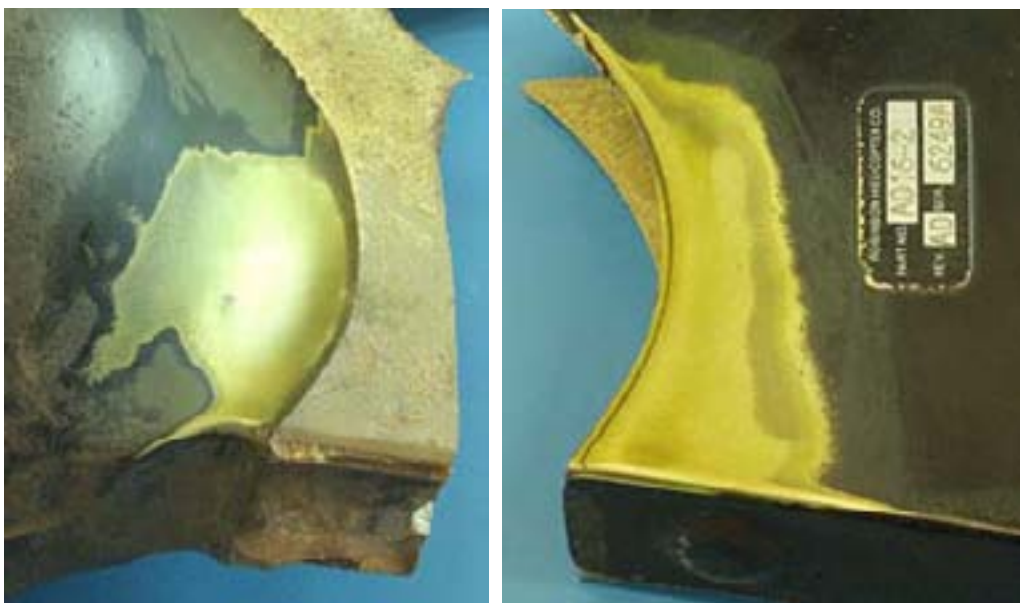
Figure 11: The location and extent of paint removal, blade s/n 6249A

No fatigue cracking had occurred in either the upper or lower blade skins adjacent to the cracking in the fitting. Paint had been removed from the lower surface of the blade, in the region of the inboard bolthole, during maintenance just prior to the final flight in an attempt to determine if a crack was present in the skin, see figure 11.

This behaviour differed from prior, similar, blade fractures in which fatigue cracking had extended into the blade skin. In place of crack propagation through the adhesive and into the skin, disbonding had occurred between the fitting and skin.

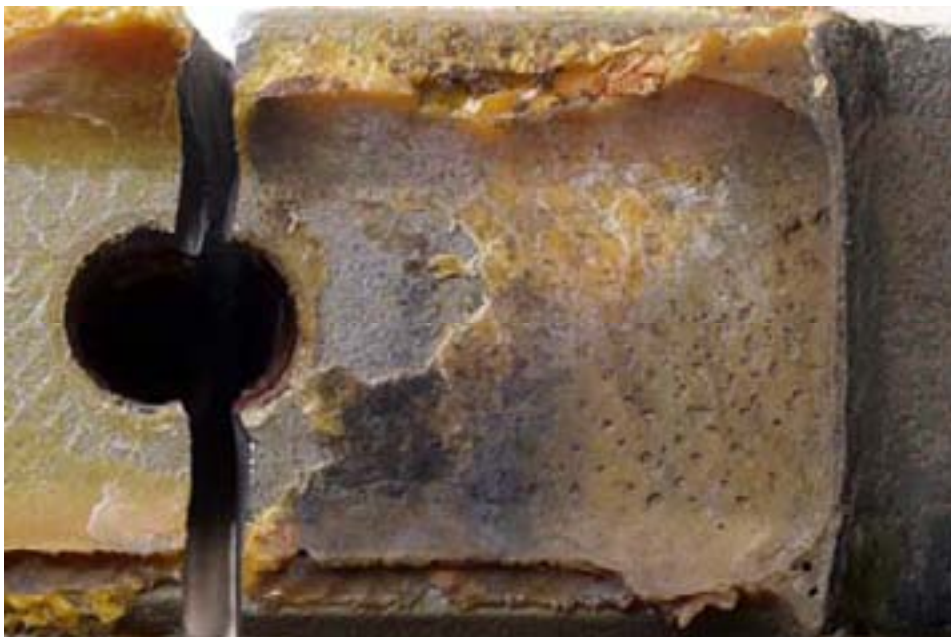
Figure 12: The extent of disbonding between the spar and root fitting, blade s/n 6249A

A feature of the failure of the main rotor blade (s/n 6249A) is the failure of the adhesive bond (disbonding) between various parts of the joint. Regions of disbonding had occurred between the end of the spar and the root fitting and at the inboard ends of the upper and lower blade skins, see figures 12 and 13.

- a) The spar and blade skins were removed mechanically from the remnant of the root fitting attached to the blade. Regions of adhesive fractured during this process can be discerned by colour (light cream) and texture (rough) from regions of inservice bond failure (dark honey, generally smooth surface)

- b) Disbonding extends beyond the inboard bolthole

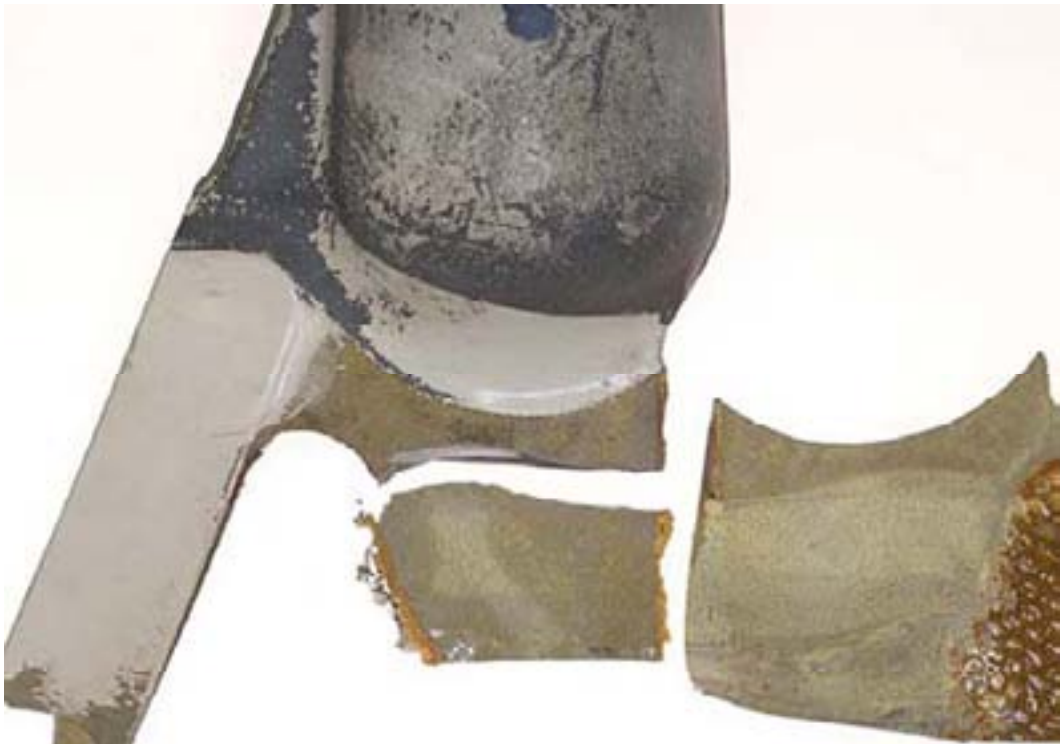
Figure 13: The extent of disbonding between the blade skins and root fitting, blade s/n 6249A

a) Disbonding extends from the inboard edge of the skin to the fracture. The paint film on the root fitting was badly weathered

b) Disbonding extends from the inboard edge of the skin to the fracture

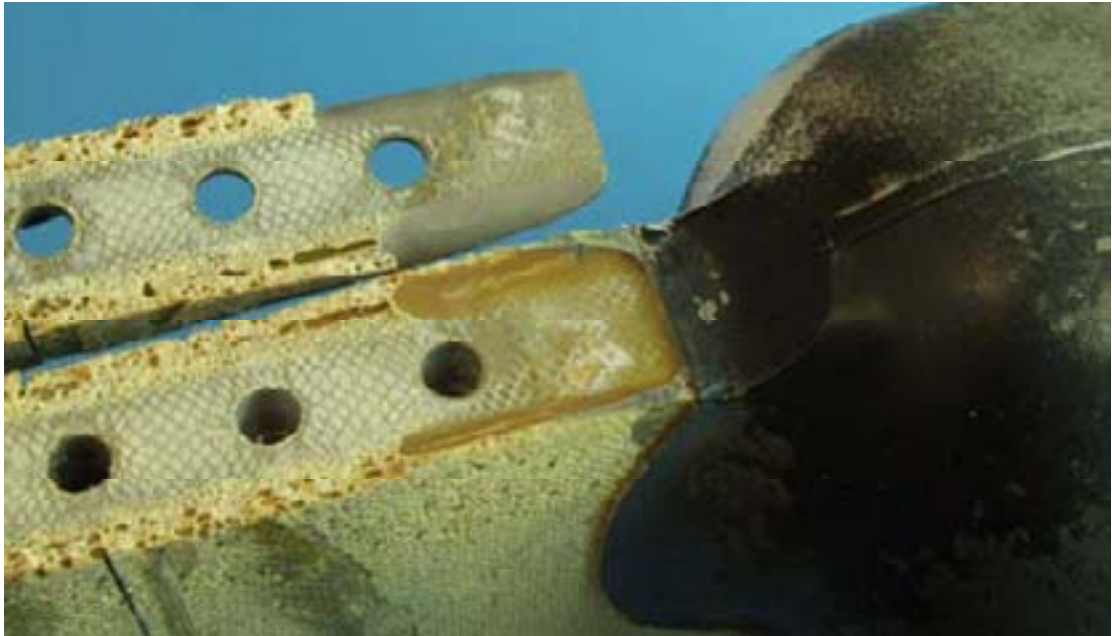
Figure 14: Extent of adhesive disbond in blade s/n 6283A (VH-OHA)

a) Disbonding has extended from the end of the spar to the edge of the inboard bolthole

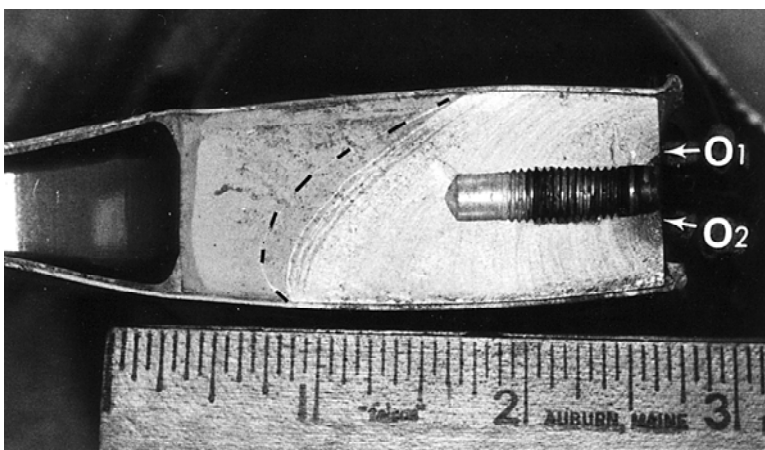
b) The root fitting fractured as a result of fatigue crack propagation from the inboard bolthole. In this case fatigue cracking initiated at the interface between the spar and the edge of the fitting (indicated by O₁ and O₂)

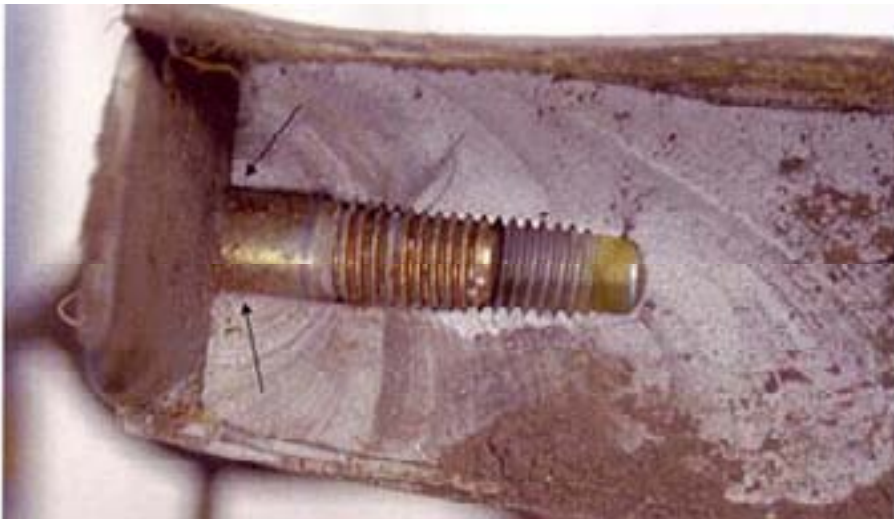
b) "The arrows indicate the location of the fracture origins on both sides of the bolt hole very close to the leading edge"

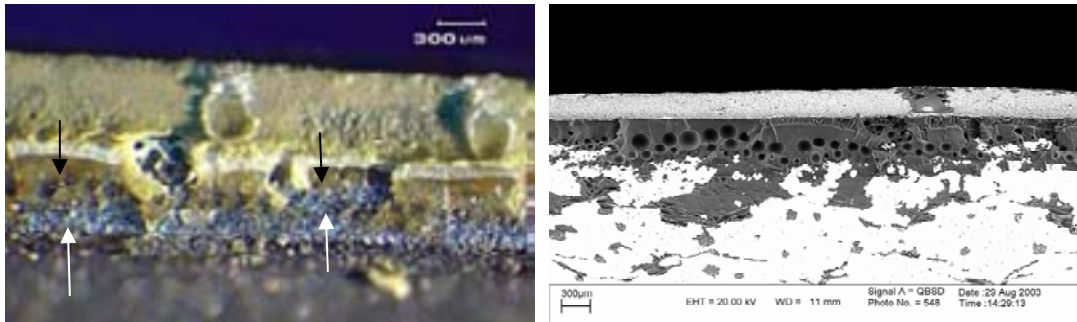
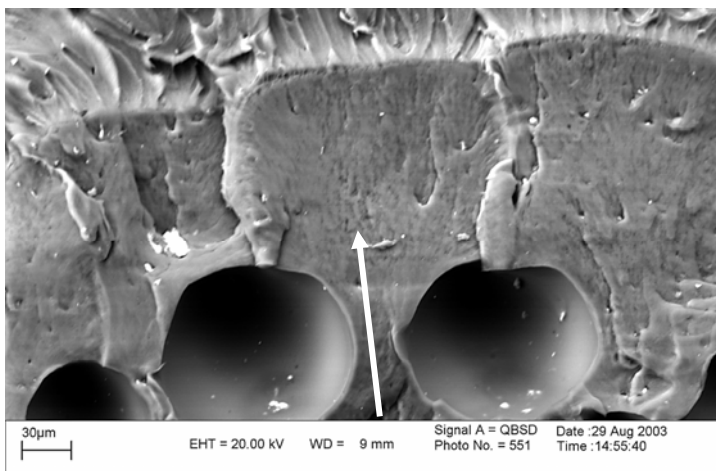
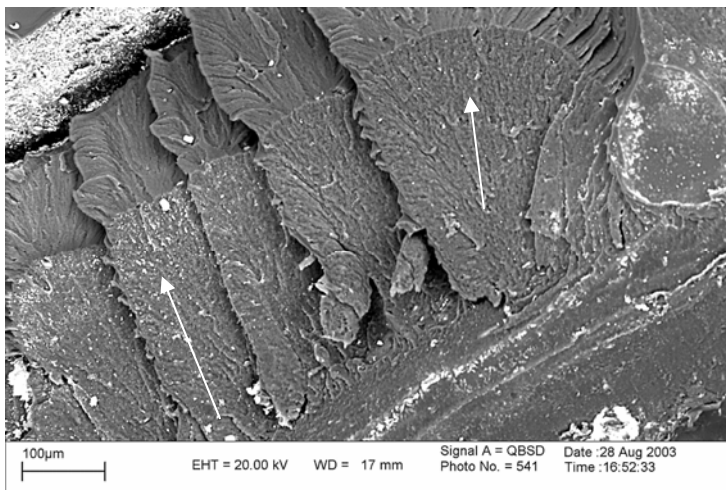
Figure 37: Examples of fatigue cracking in the adhesive fillet at the end of the adhesive joint

a) VH-HCO, s/n 11277B, the extent of fatigue cracking is arrowed (light micrograph at left, scanning electron micrograph at right)

b) VH-HCO, s/n 11277B, the direction of fatigue crack growth is arrowed

c) VH-LOT, s/n 8411B, the direction of fatigue crack growth is arrowed

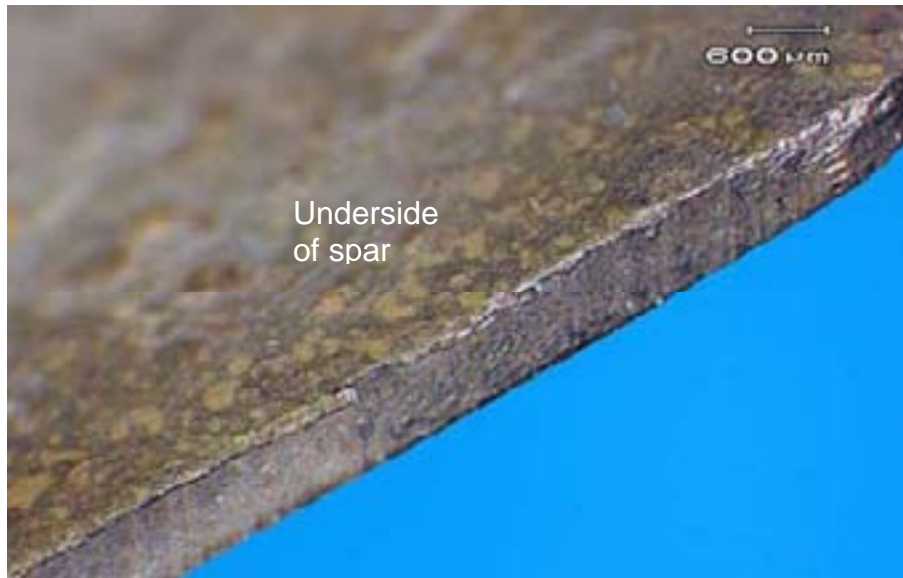
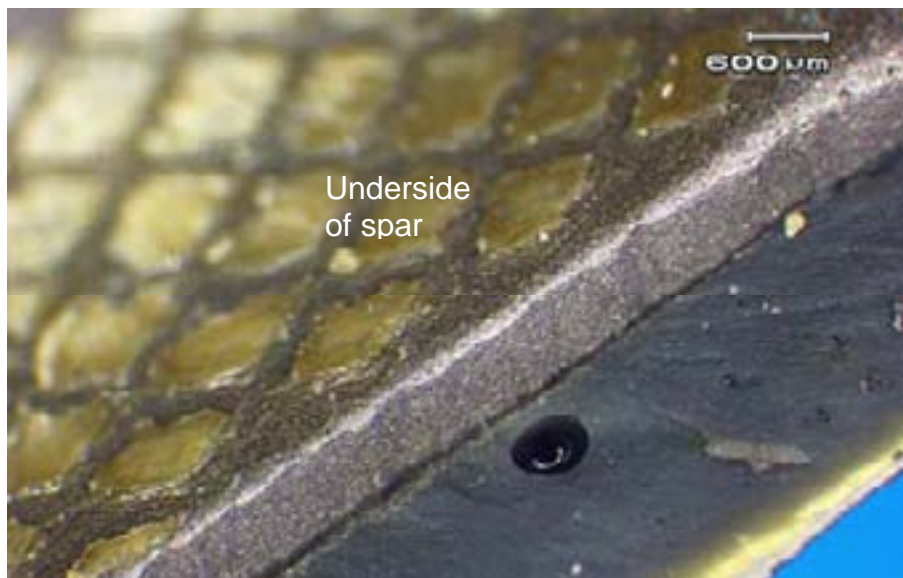
Figure 38: Examples of the geometric and surface finish variations at the spar end

a) VH-OHA, s/n 6249A, fractured blade, showing a sharp corner between the spar end and the bonded surface, and, in addition, minimal surface roughening by grit blasting

b) Blade s/n 8603B, showing a rounded corner between the spar end and bonded surface, plus surface roughening by grit blasting

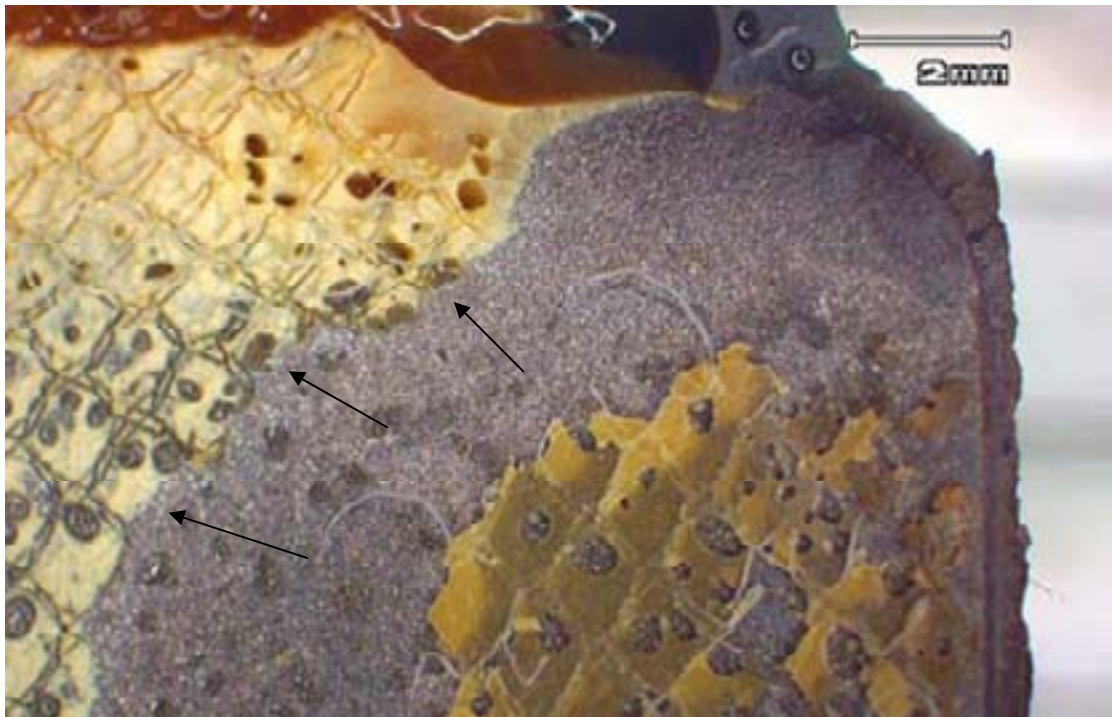
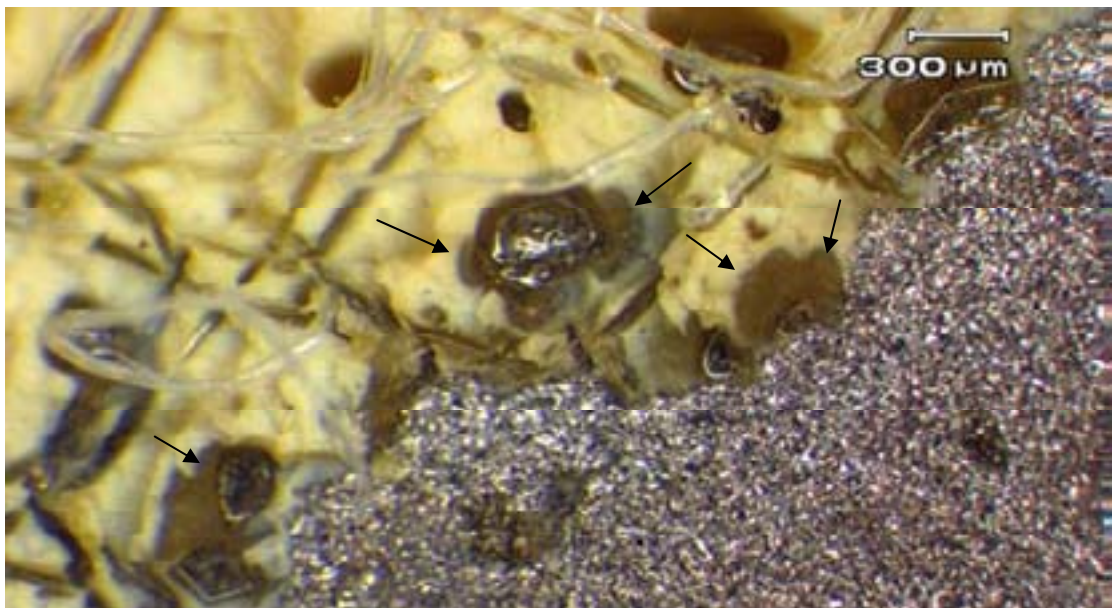
Figure 39: Photomacrographs of the disbond boundary, blade s/n 12616B

a) The disbond boundary is arrowed.

b) Regions of crack growth from voids near the disbond boundary are coloured darker than the region of fracture induced in the adhesive during strip down, examples are arrowed. The clear fibres are from the scrim fabric used in the manufacture of the adhesive film.

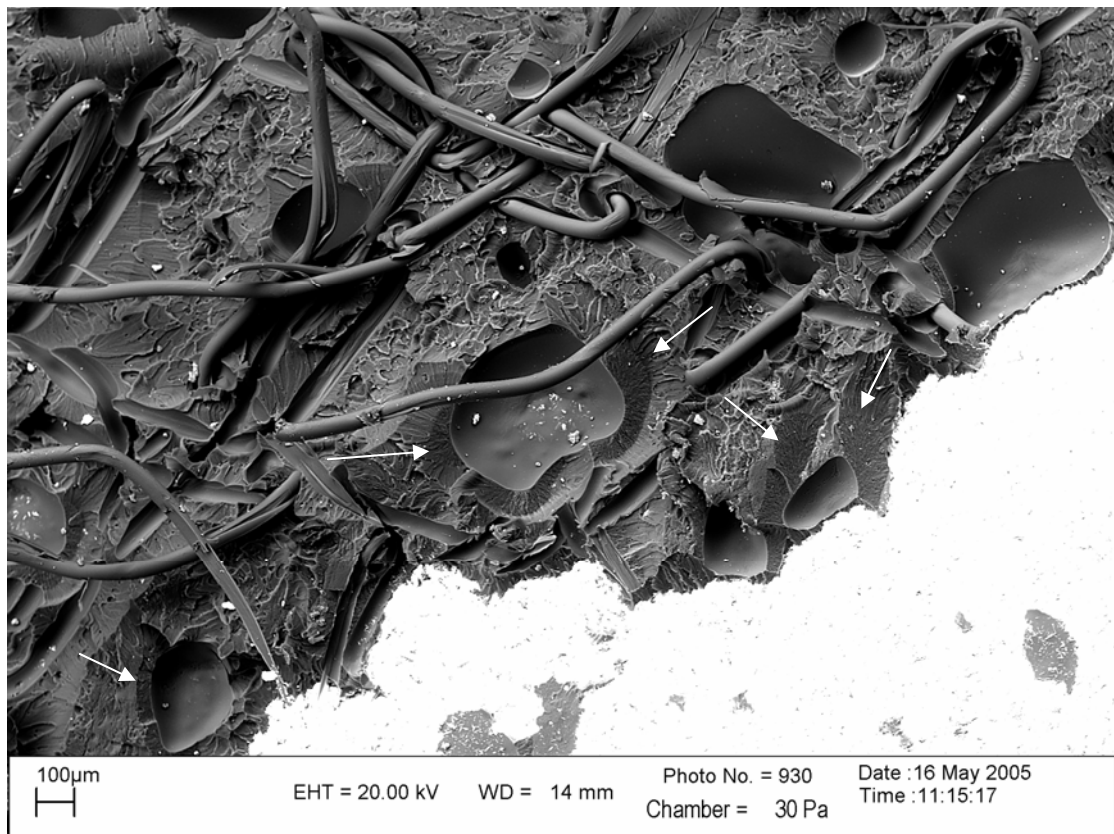
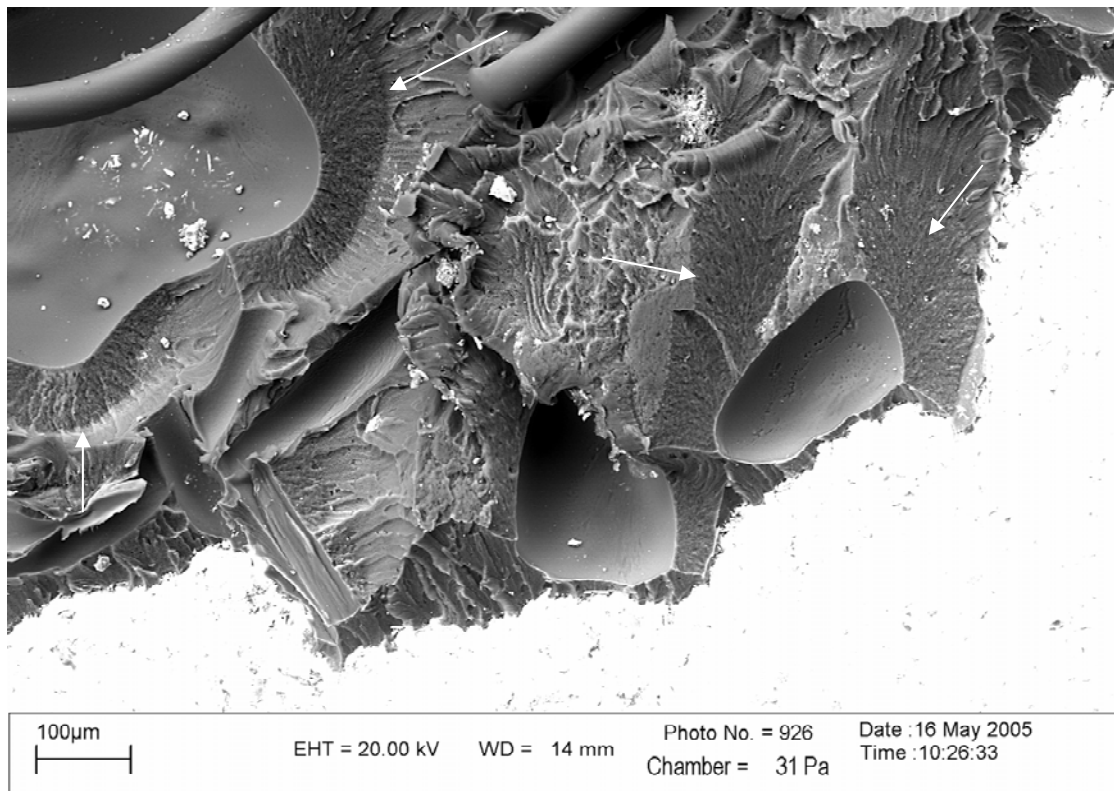
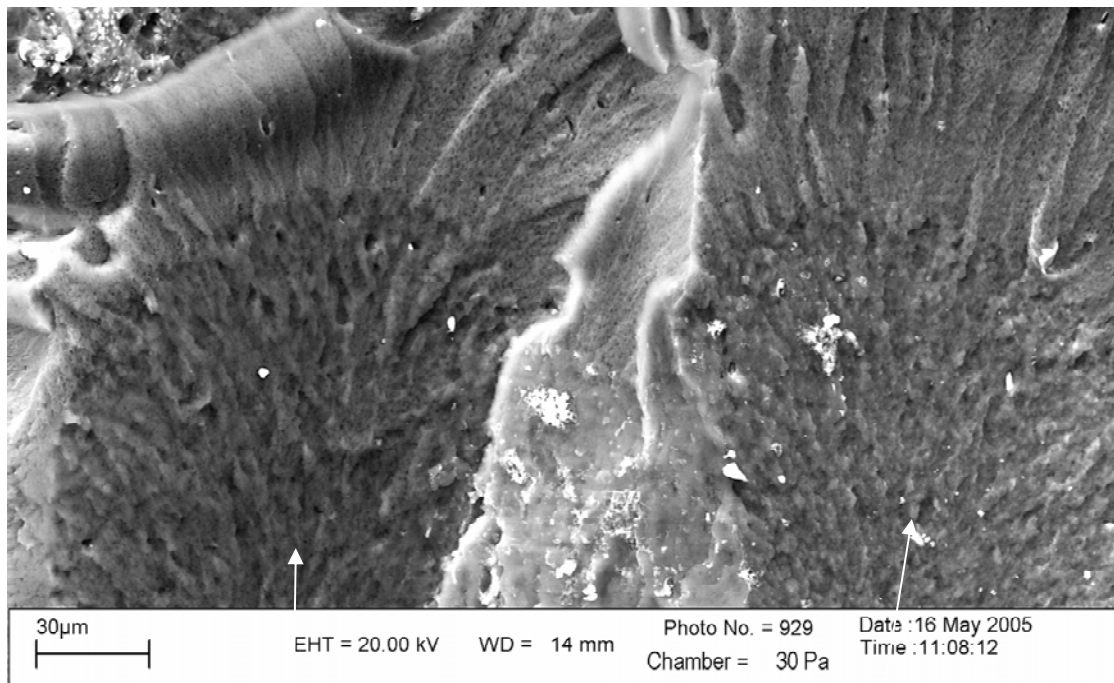
Figure 40: Scanning electron micrographs of the disbond boundary, blade s/n 12616B

a) Regions of crack growth from voids near the disbond boundary are arrowed

b) Region of Figure 40a at higher magnification, crack growth from voids is arrowed,

c) The boundary between a region of progressive crack growth (lower half of the micrograph) and induced tearing (upper half of the micrograph), the direction of crack growth is arrowed

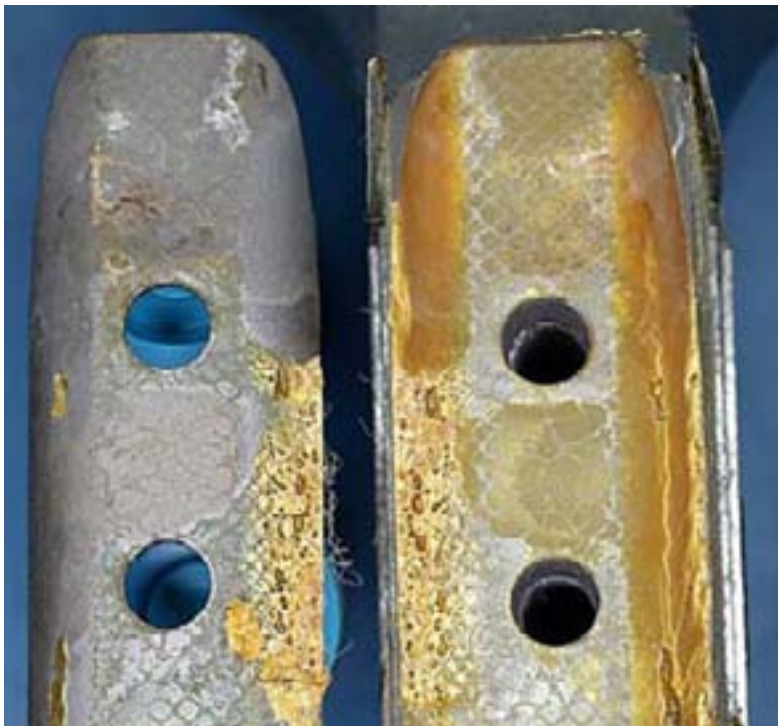
b) VH-LOT, s/n 8414B. Extensive disbonding has occurred, including disbonding between the two boltholes. However disbonding has not extended to the edge of the inboard bolthole.

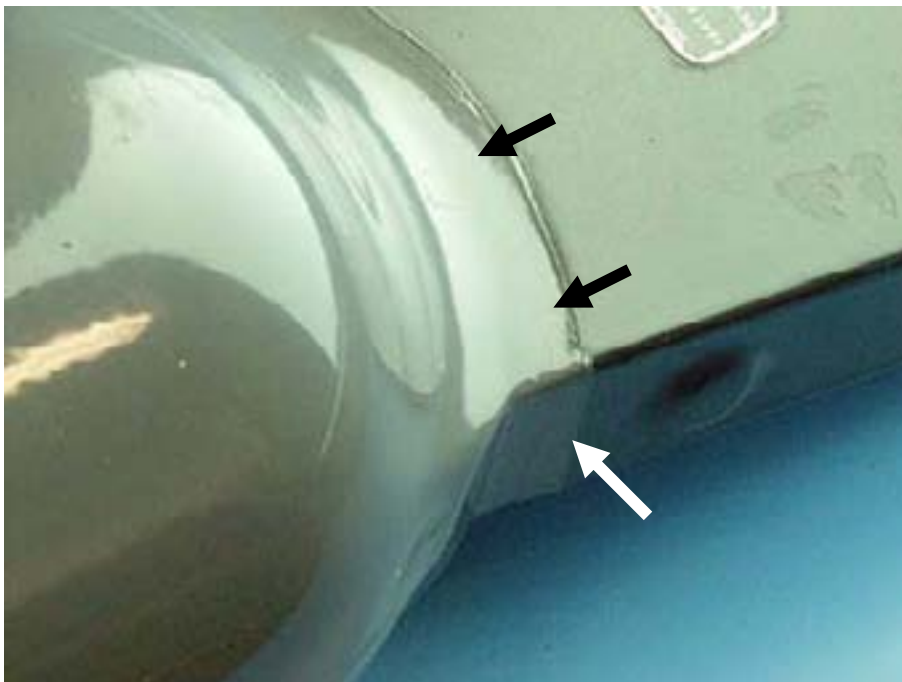
Figure 3. Cracks in filler at the end of the spar and lower skin

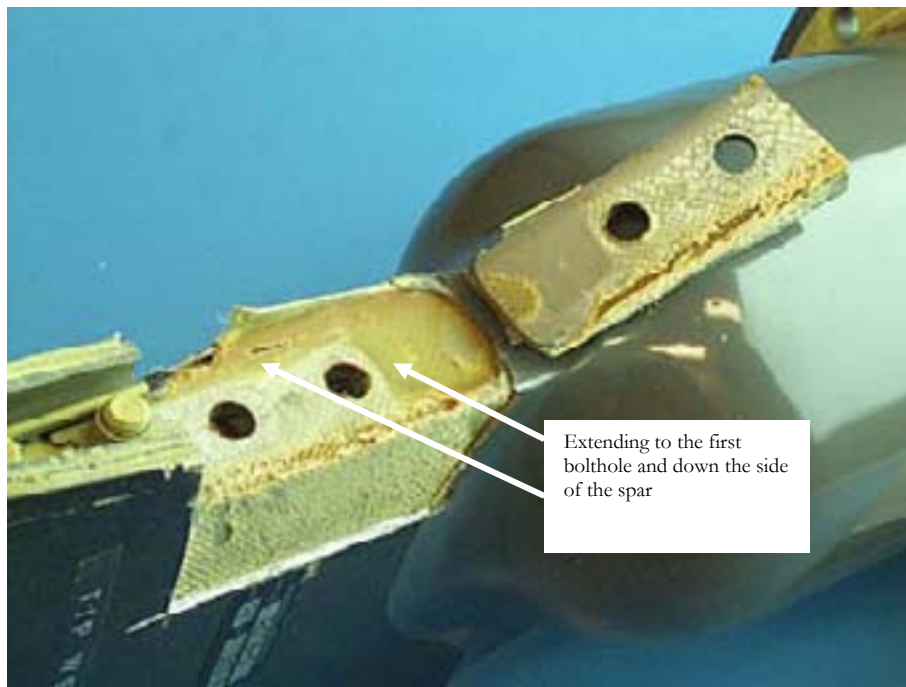
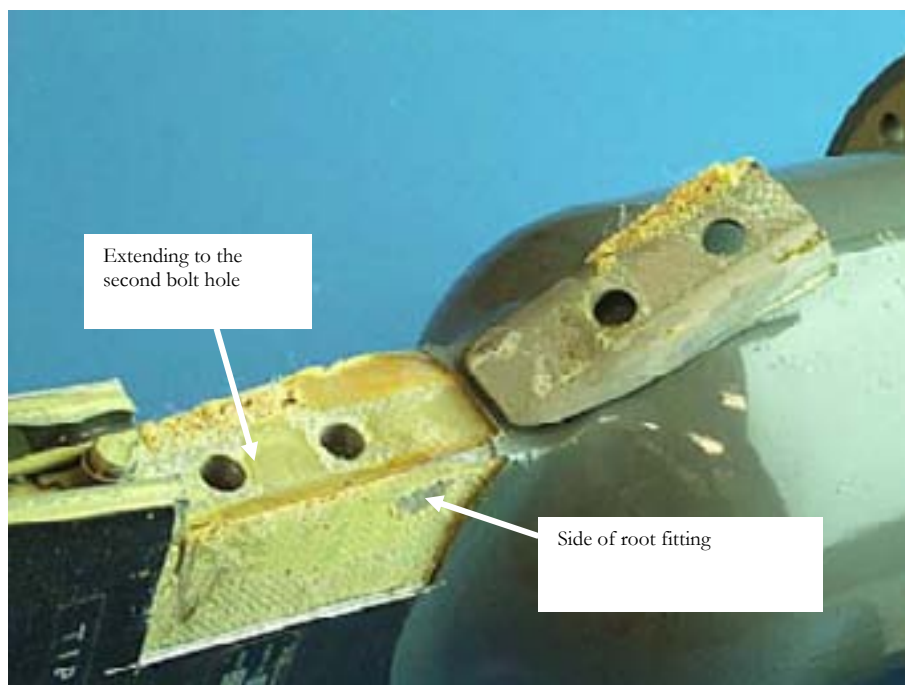
Figure 6. Examples of varying extents of adhesion failure (debonding)
