Separation Anxiety

Can we prevent these catastrophic head-to-barrel separations?

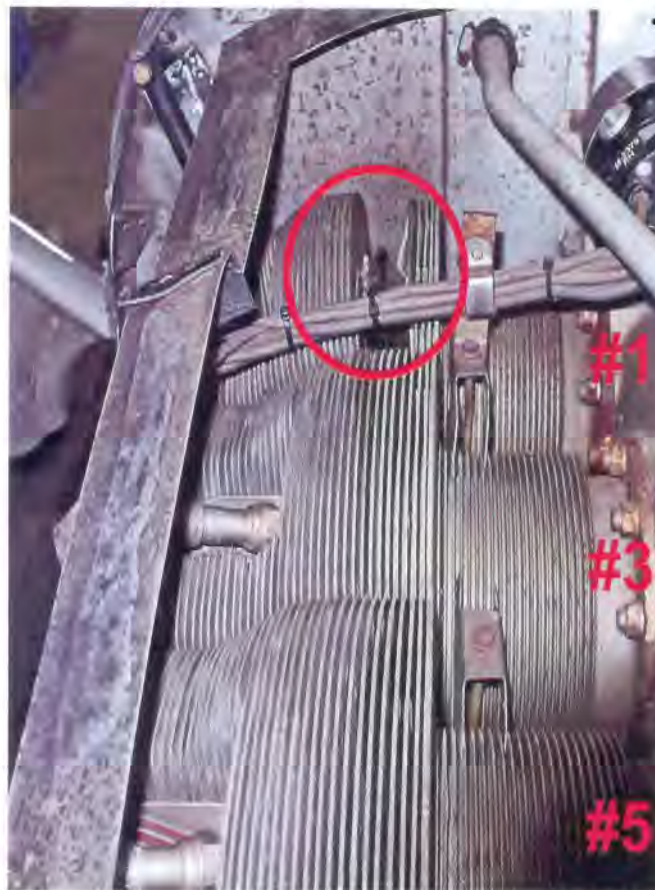
Figure 1— The #1 cylinder head on this TCM O-470-U engine suffered a catastrophic fatigue failure in flight. The #3 cylinder suffered a similar failure about an hour later!

The mechanic at Dickenson Air Services had a replacement cylinder overnighted by FedEx and installed the next day by lunchtime. The Skylane owner did a 20-minute test flight with the new cylinder, followed by an inspection and leak check, and continued his trip...or so he thought. About 40 miles after takeoff, the same thing happened again, but this time it was the #3 cylinder that blew its top. The owner made another emergency landing, this time at an unattended airstrip in Beach, North Dakota. By now he'd had enough, and

The cylinders that failed on this O-470-U engine were apparently Continental factory jugs. But cylinders from other manufacturers like ECI and Superior were also suffering similar fates from time to time. In fact, it wasn't long afterwards that the FAA had Superior Millennium cylinders boresighted in their rulemaking machinery.

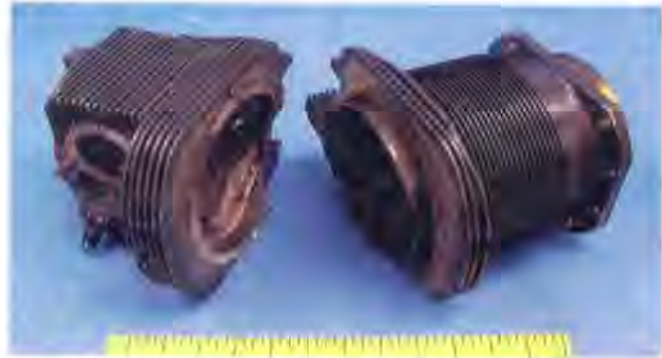
Figure 2—Head-to-barrel separations are not limited to Continental engines. Here's a Lycoming cylinder that lost its head. (NTSB photo.)

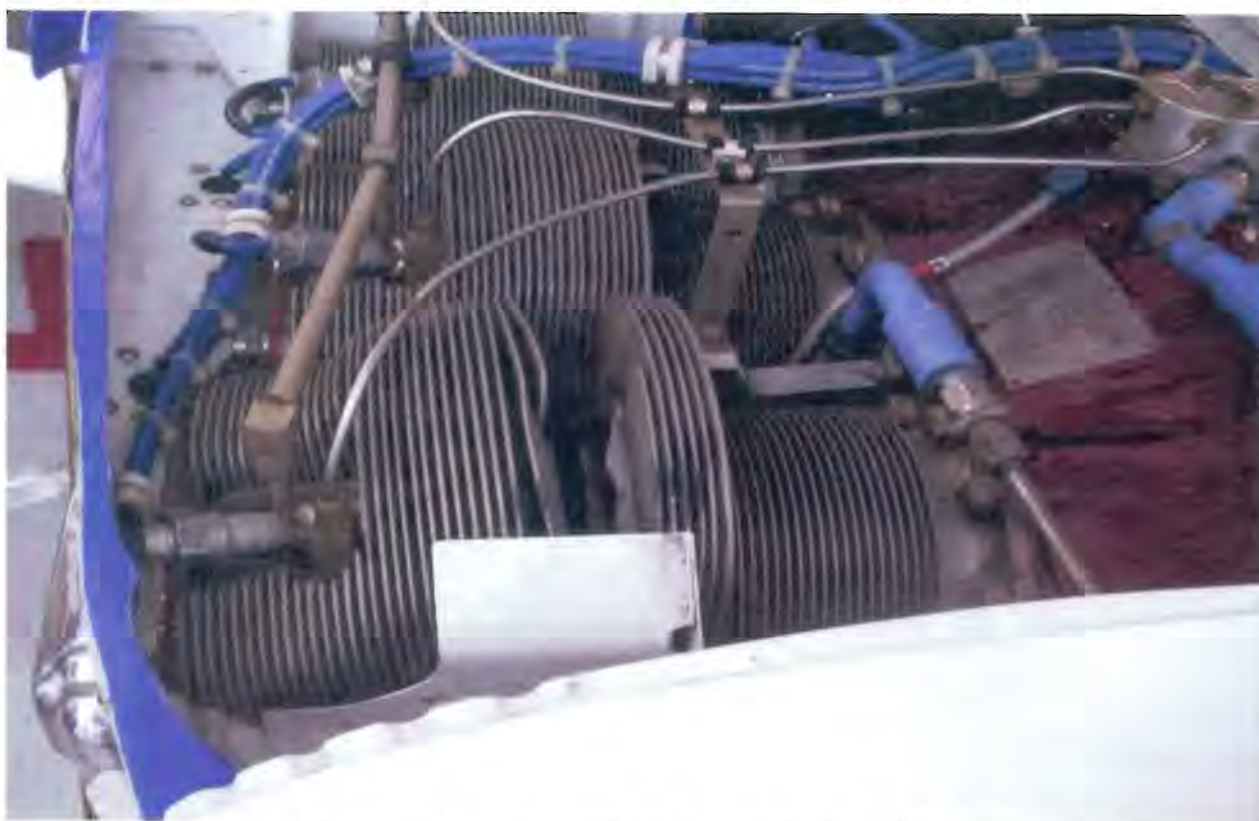
Figure 3— Head-to-barrel separation of #5 cylinder on a Continental TS10-520 engine.

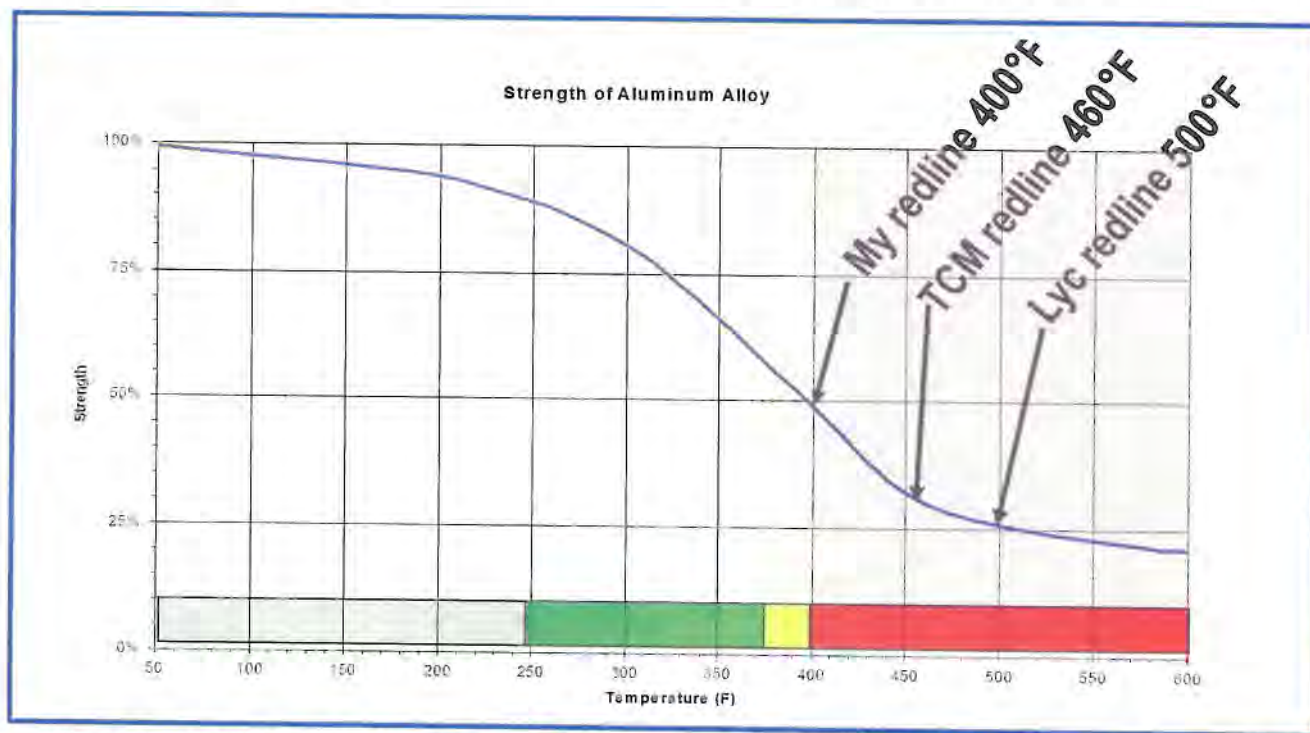
Figure 4— At 400°F, the head casting loses half of its strength; by 500°F, it loses three-quarters of its strength.

I've long been convinced that the key to cylinder longevity lies in keeping the cylinder heads cool. The tensile strength of aluminum alloys drops sharply as temperature increases. (See Fig. 4.) At 400°F, the head casting loses half of its strength; by 500°F, it loses three-quarters of its strength. As regular readers of this column know, I'm obsessive about keeping my CHTs well-controlled. I always try to keep all CHTs at 380°F or less. The CHT alarm on my JPI engine monitor is set to go off at 390°F, and when it does, I take immediate action to bring the CHT down: I lower the nose if I'm climbing, open the cowl flaps, richen the mixture if I'm ROP, lean more if I'm LOP...whatever it takes.

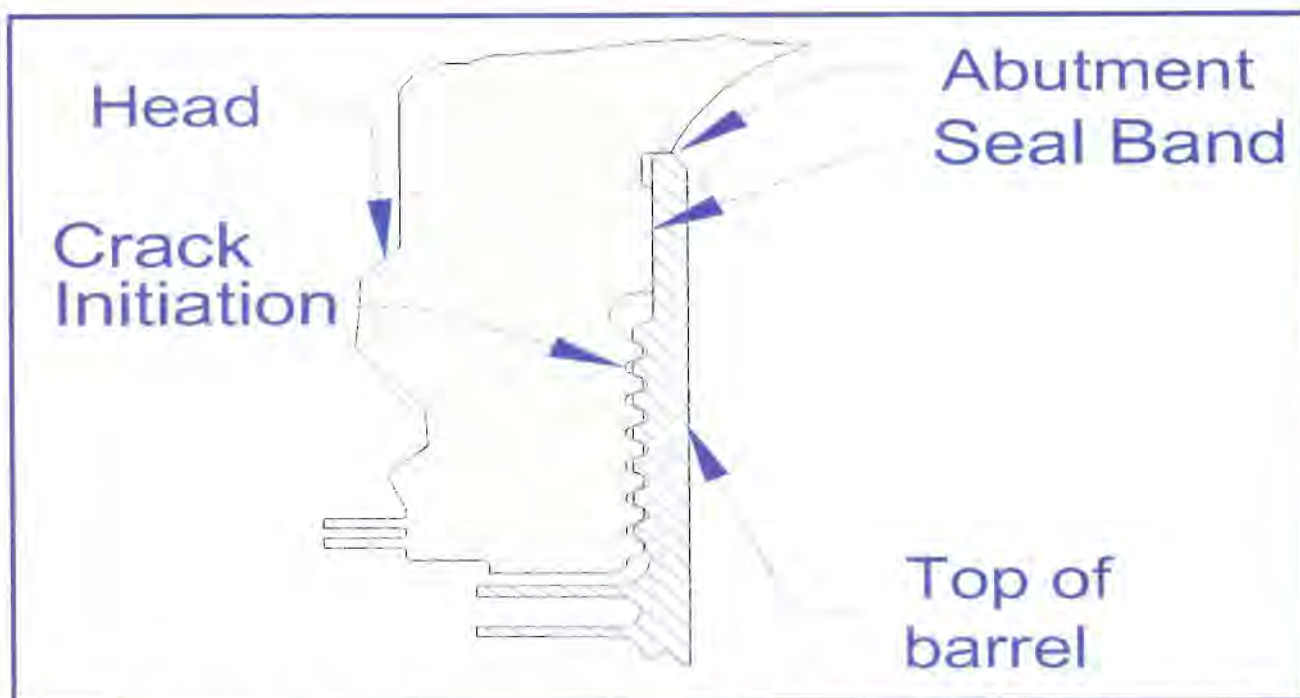
Figure 5— Continental cylinder head-to-barrel junction. The strength lies in the interference fit of the non-threaded “seal band.” If the seal band loses its grip, crack initiation occurs at the topmost thread. (Diagram courtesy of ECI)

onto the barrel. During manufacture, the head casting is heated in an oven to about 650°F, while the barrel is chilled in a refrigerator. The hot head and the cool barrel are then quickly screwed together until the top of the barrel bottoms out against the abutment surface of the head casting. As the temperatures of the head and barrel equalize, the head shrinks and the barrel expands to create an "interference fit" that locks the two together permanently. (See Fig. 5.)

I'd long been under the impression that it was the threads that held the head and the barrel together, but it turns out that's not quite true. The real strength of the head-to-barrel junction lies in the non-threaded area above the threads, variously known as the "seal band" or "friction band" or "shrink band." It is primarily the friction of the interference fit in the seal band area that gives the junction its strength. In fact, ECI's current specs provide for a slightly tighter interference fit at the seal band (by a few thousandths of an inch) because their testing revealed that this creates a more robust junction.

Now, it turns out that the “tightness” of the interference fit is a function not only of manufacturing tolerances, but also of CHT. As the cylinder temperature rises, both the head and barrel expand. But because the coefficient of expansion of aluminum is about twice that of steel, the head expands twice as much as the barrel. Thus, as CHT increases, the interference fit of the head-to-barrel junction loosens. If the CHT becomes high enough, the seal band can start to lose its grip, transferring stress to the threaded portion of the junction. When that happens, the top thread takes the lion’s share of the stress, and ultimately a crack will initiate at that location that can grow over time to the point that the junction fails catastrophically.
