APPENDIX A: MAIN ROTOR BLADE FAILURE ANALYSIS REPORT

ENGINEERED SYSTEM FAILURE ANALYSIS REPORT

MAIN ROTOR BLADE FRACTURE ROBINSON R22, VH-OHA OCCURRENCE 200302820

2 November 2005

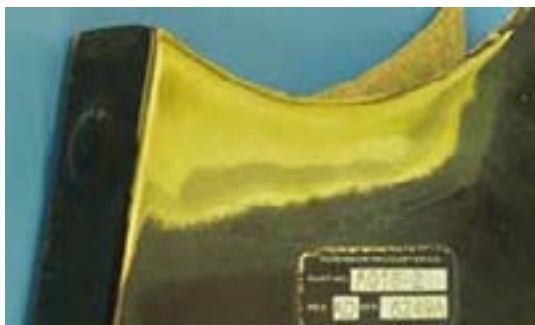
a) fractured blade

Main rotor blades are identified by a part number and a serial number. These numbers are recorded on a decal attached to the lower blade surface near the blade root. The fractured blade was identified as p/n A016-2, rev. AD, s/n 6249A, see figure 3. The other main rotor blade fitted to the helicopter at the time of the accident was identified as p/n A016-2, rev. AD, s/n 6283A, see figure 3. The serial numbers of the blades were cross checked with the serial number engraved on a normally enclosed part of the blade structure.

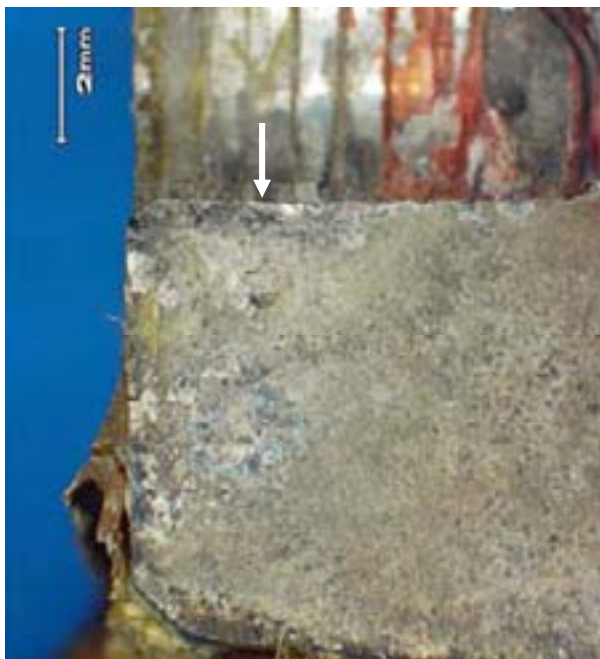
The nature of crack progression markings indicate that fatigue crack initiation occurred first at the lower side of the bolthole, secondly at the thread on the upper side of the bolthole and thirdly at the counterbore on the upper side of the bolthole.

c) First initiation site

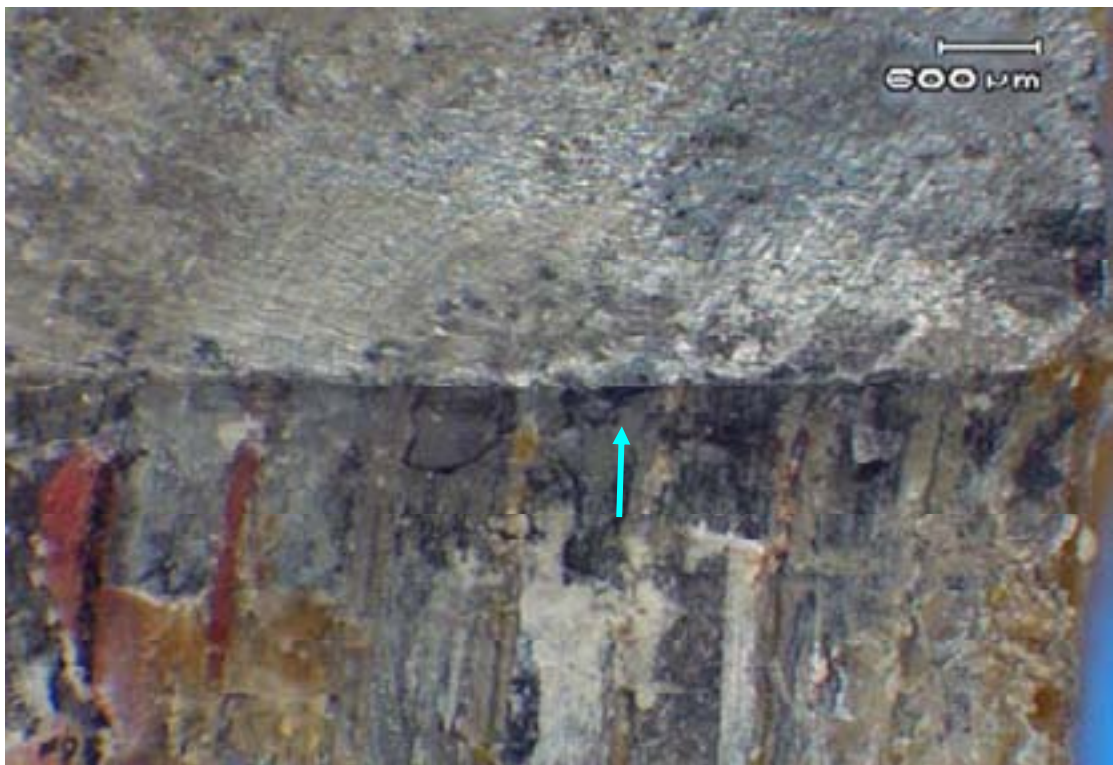
Fatigue crack initiation was associated with localised corrosion. It was not associated with the remnant of the thread.

Figure 9: Extended focus light microscope image of the first initiation site

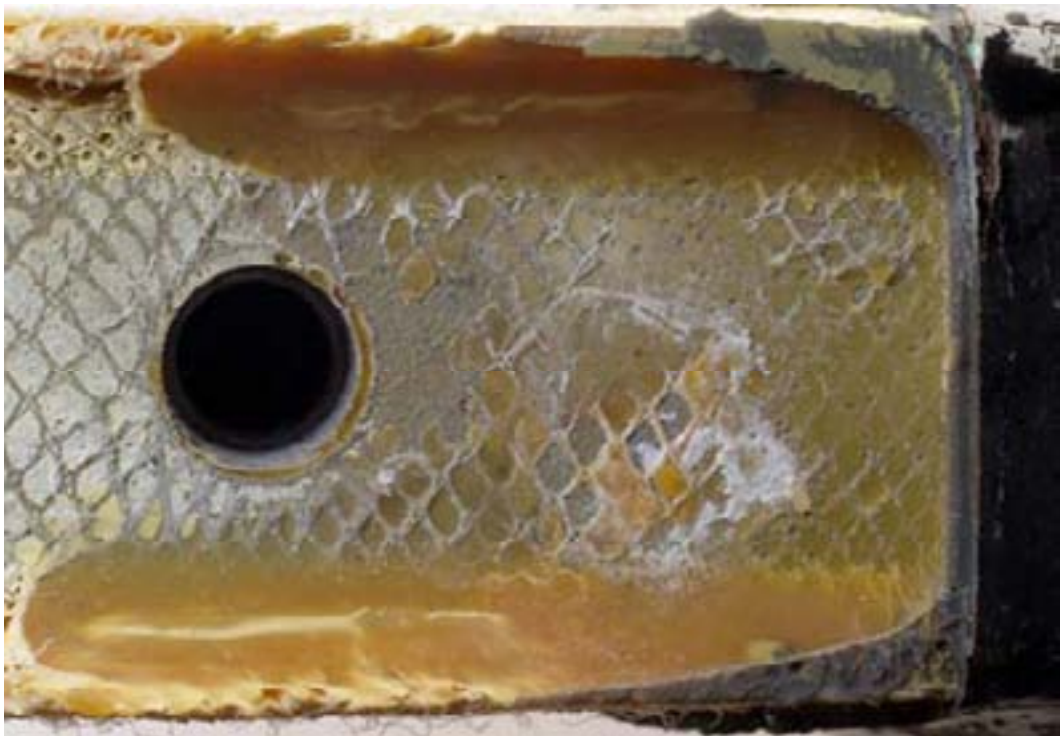
b) Detailed view of the region between the inboard bolthole and spar end

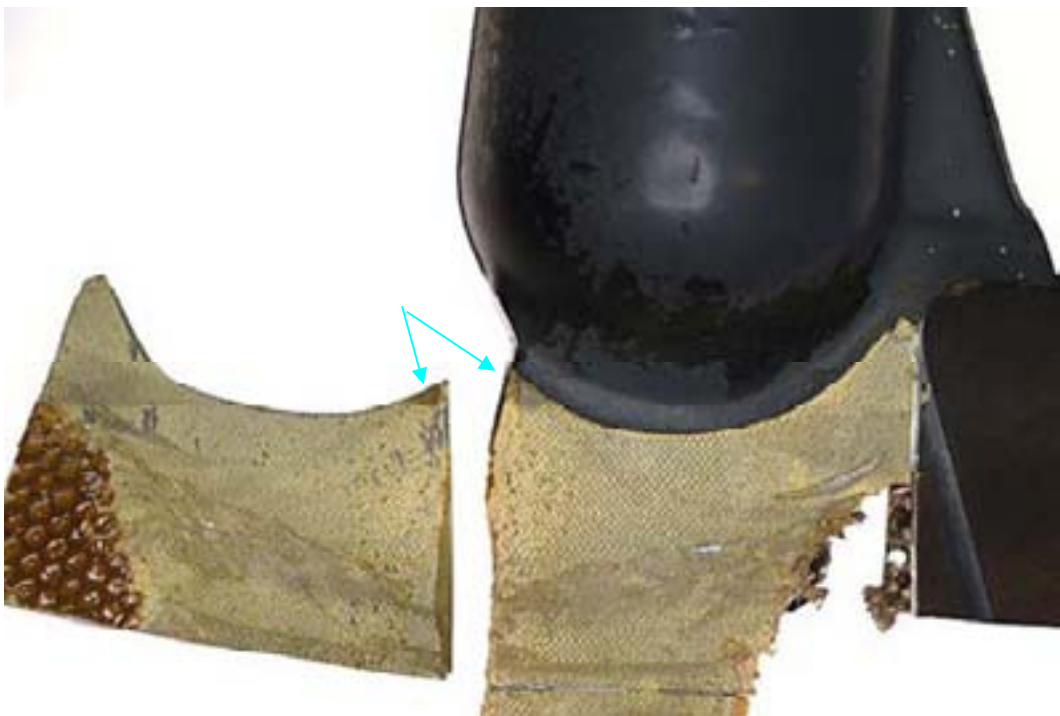
Figure 15: The nature of the adhesive bond between the upper and lower blade skins, blade s/n 6283A

b) Only a small region of adhesive disbonding was present, arrowed

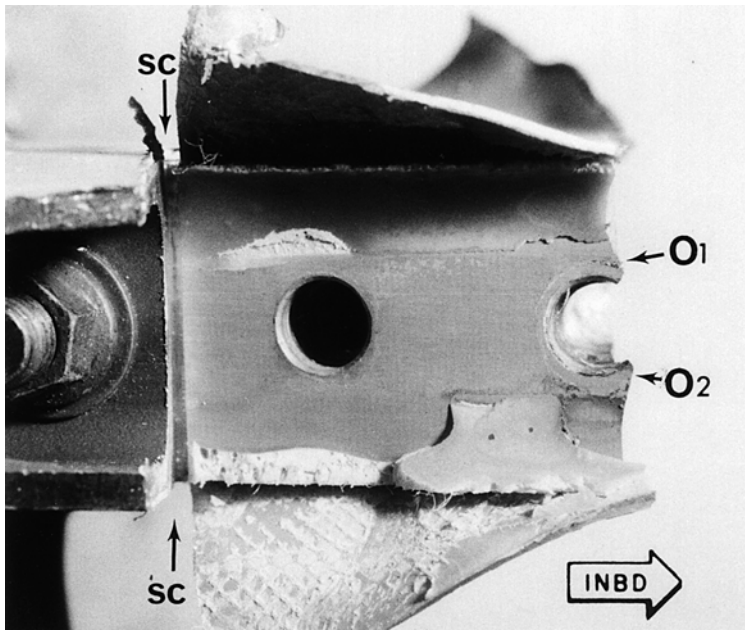
c) The spars of blades manufactured to the configuration of A016-1 were not adhesively bonded to the fitting

Investigation of this blade failure revealed that fatigue cracking initiated from two region of fretting damage on the edge of the root fitting.

As a result of this failure the blade was redesigned to the A016-2 part number configuration. The redesigned blade was extensively tested to establish a new life limit.

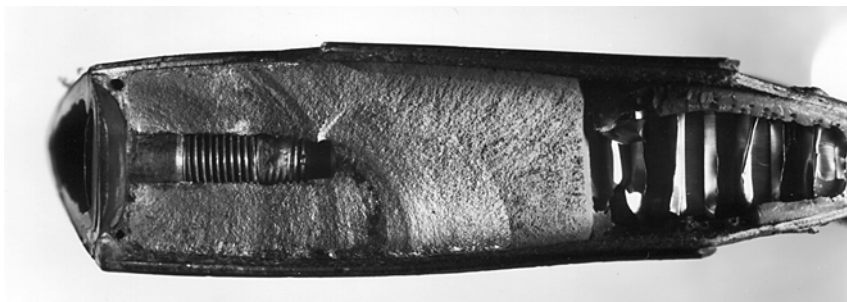
b) The blade side of the fracture

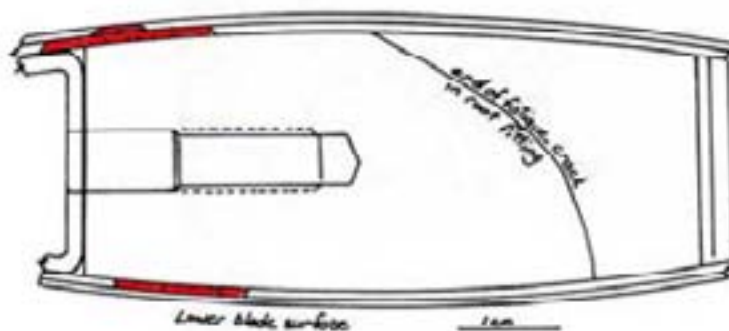
c) The regions coloured red show the extent of fatigue crack growth in the blades skins

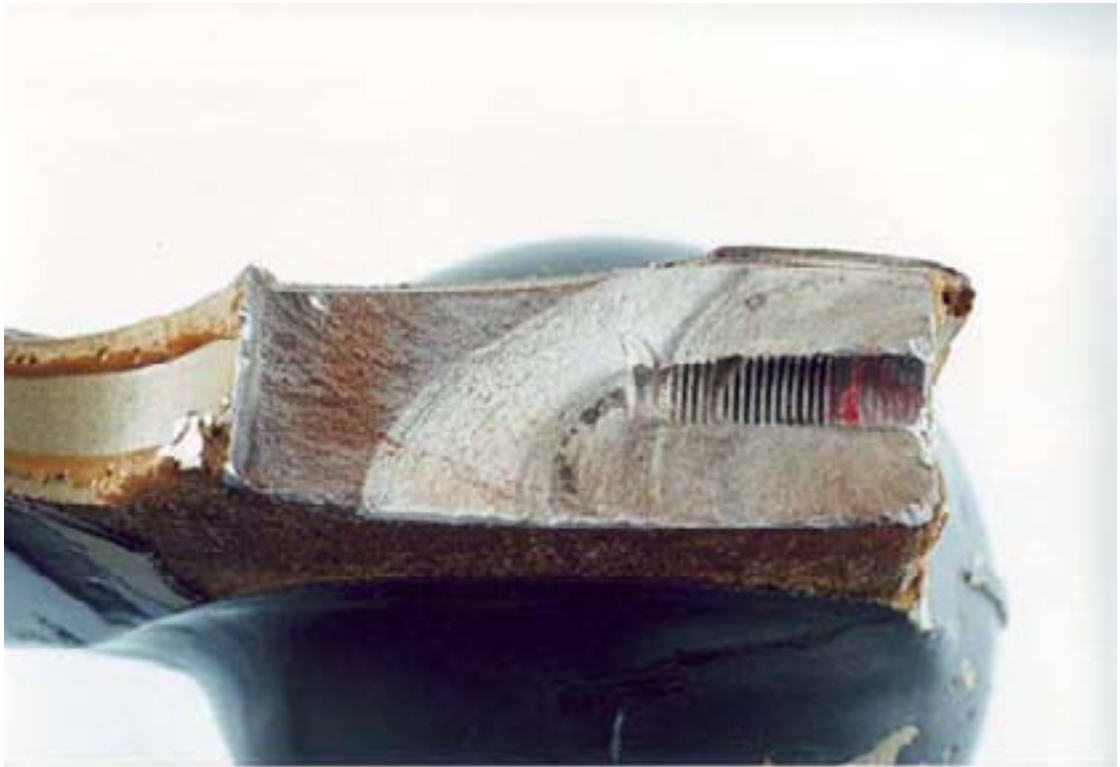
d) The root fitting side of the fracture, as recovered

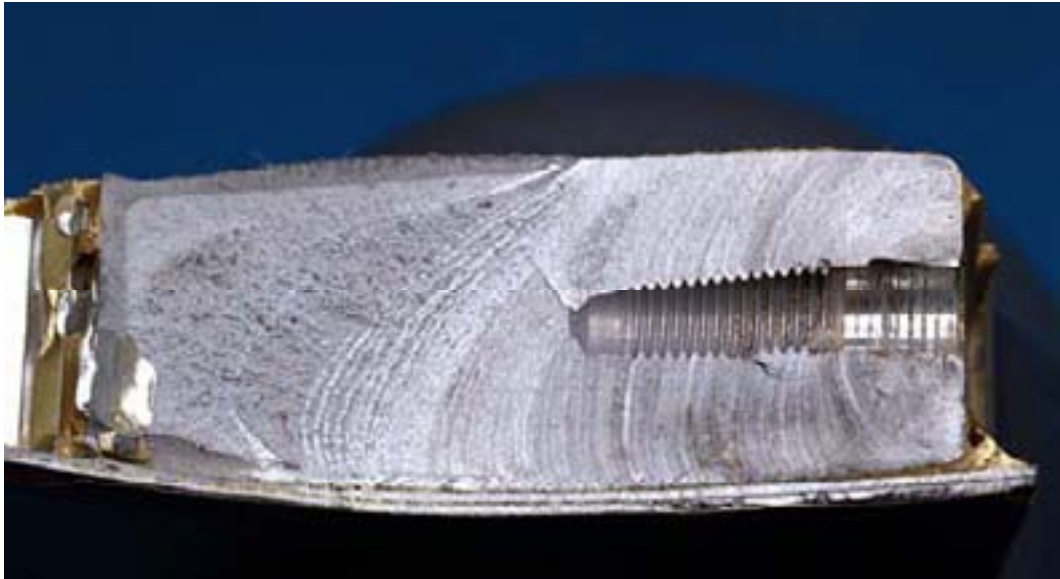
a) The root fitting side of the fracture

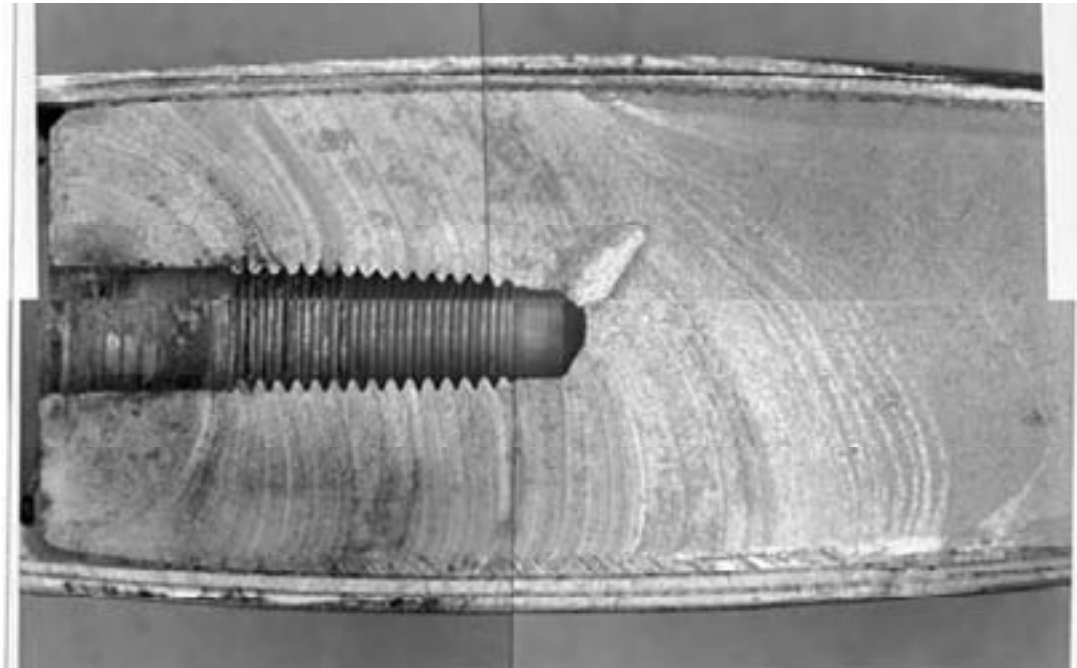
b) The blade side of the fracture

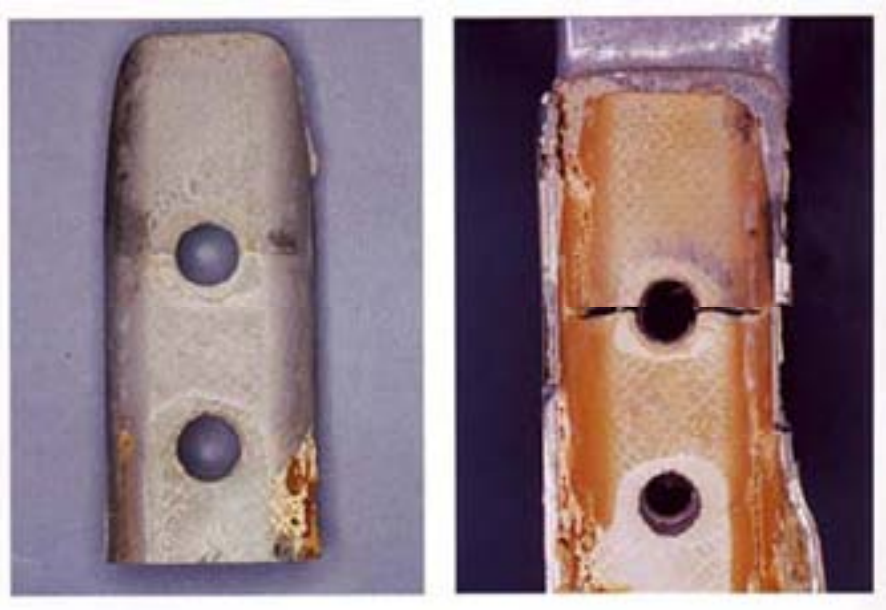
a) Fractured blade 9278B

Figure 24: Photographs showing the extent of disbonding between the spar and fitting for both blades fitted to the helicopter (VH-LDR)

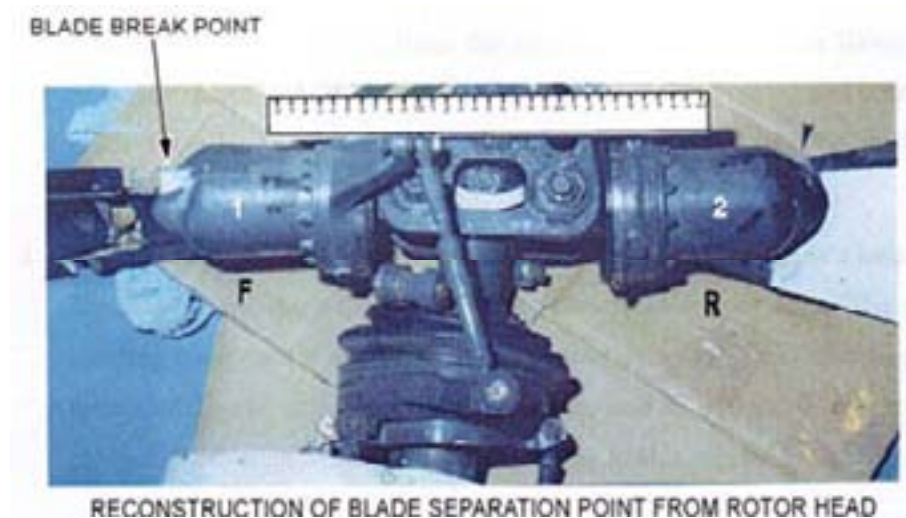
a) Fracture location

Fracture occurred during forward flight, power line survey.

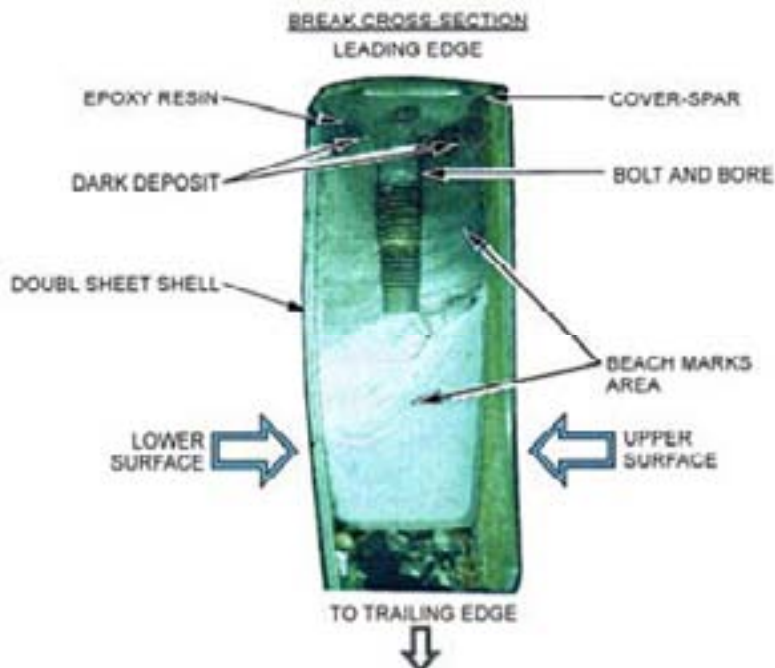
b) Fracture surface

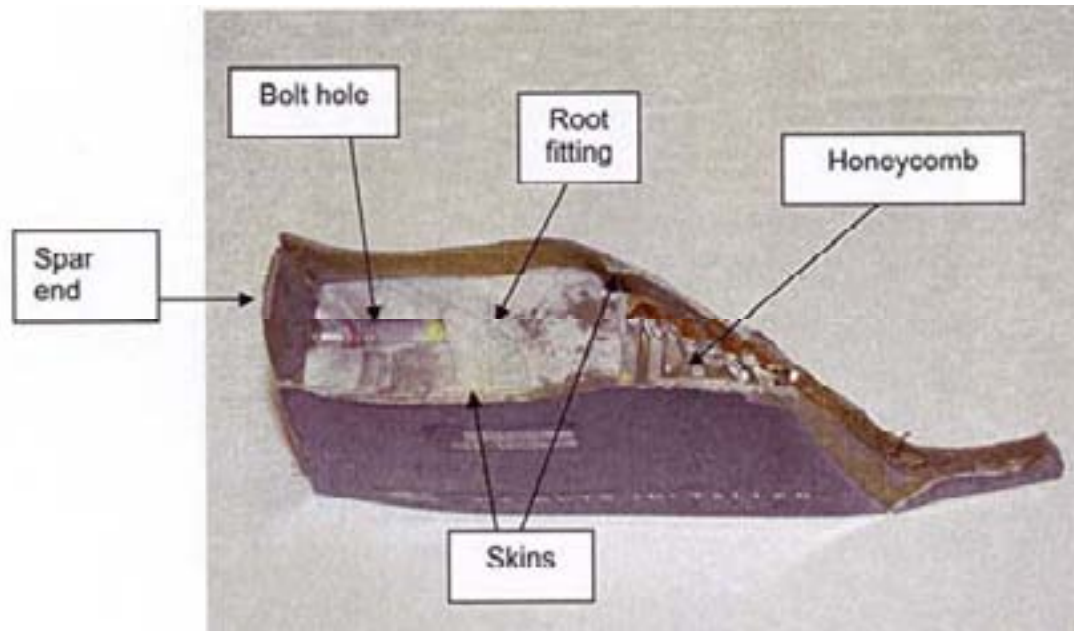
Fracture occurred just after takeoff, close to the ground.

a) The blade side of the fracture

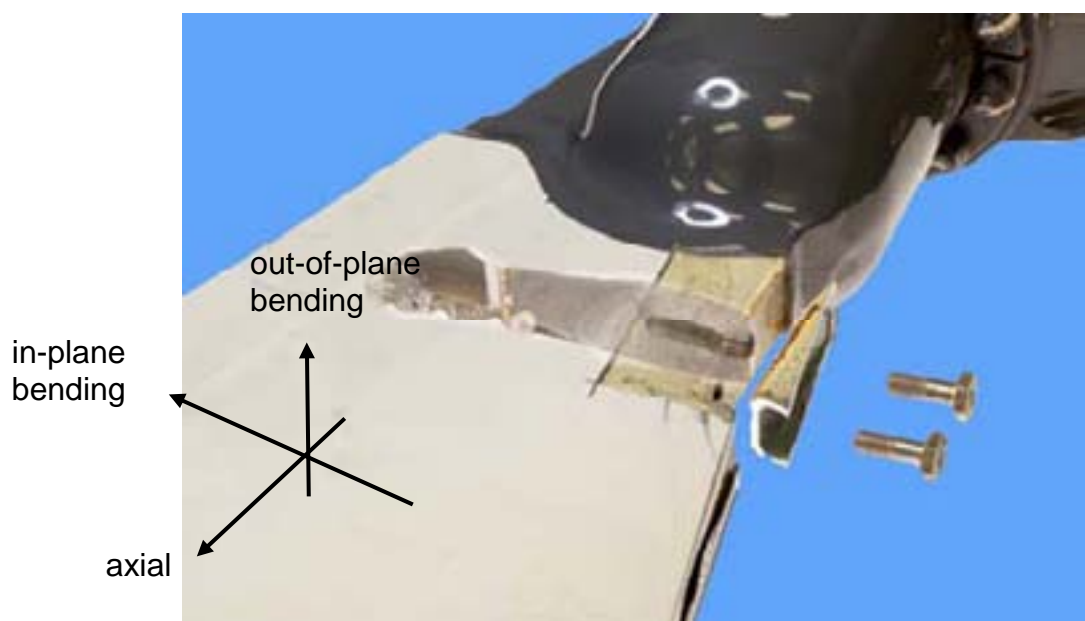
A number of observations of the nature of fatigue crack initiation and growth in R22 main rotor blades indicate that stress gradients are present in the root fitting at the location of the inboard bolthole. The asymmetry of the crack front with respect to the chordwise axis of the blade - greater crack extension in the lower half of the blade – is consistent with higher stresses in the lower half of the blade. Fatigue crack initiation in the counterbore region close to the forward edge of the fitting as opposed to crack initiation from sites further down the threaded hole may also be consistent with the presence of higher stresses near the blade leading edge.

Figure 29: Composite photograph showing the orientation of the plane of fatigue cracking with respect to the blade axes and the direction of blade loads

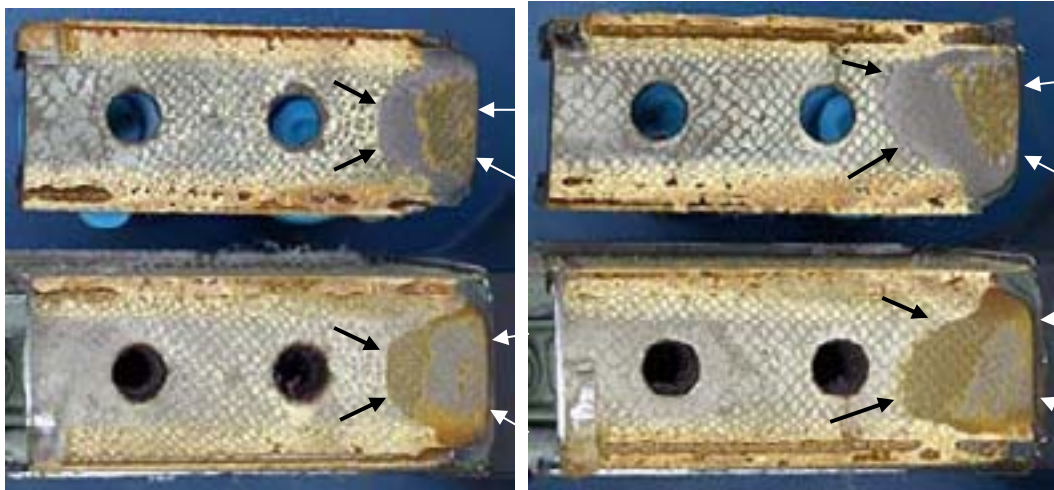
a) VH-UXF, 12616B

Figure 31: The extent of disbonding between the root fitting and inboard end of the blade spar – helicopters used in cattle mustering operations

Regions of disbond are characterised by the darker, honey brown colour and regions where the metallic surface of the spar is exposed. Regions where the intact bond was fractured during the strip down process are characterised by a light cream colour and a rougher appearance. The cross-hatched appearance of the adhesive is an effect of the scrim cloth used to create the adhesive film. The regions of adhesive disbond are arrowed.

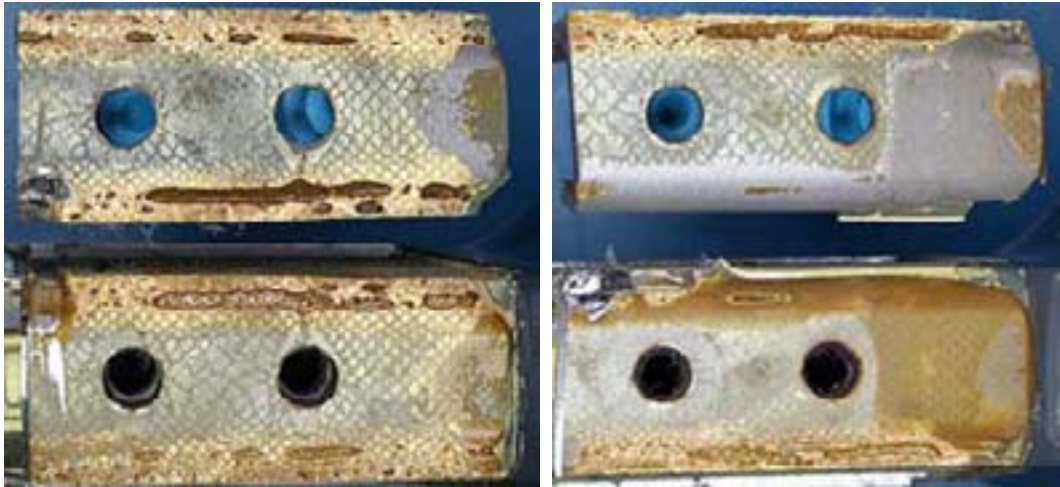
Figure 32: The extent of disbonding between the root fitting and inboard end of the blade spar – helicopters not used in cattle mustering operations

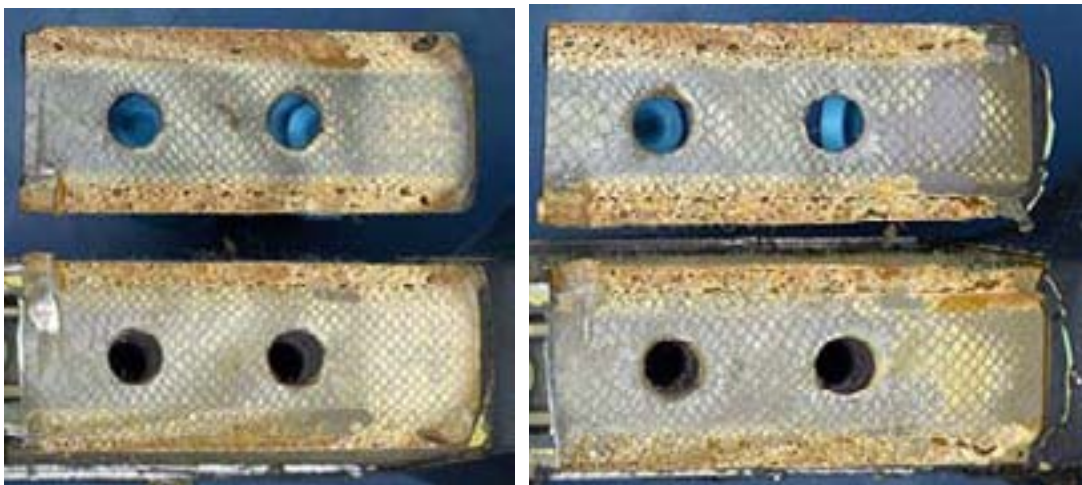
Figure 33: The extent of disbonding between the root fitting and inboard end of the blade spar – helicopter operational details unknown

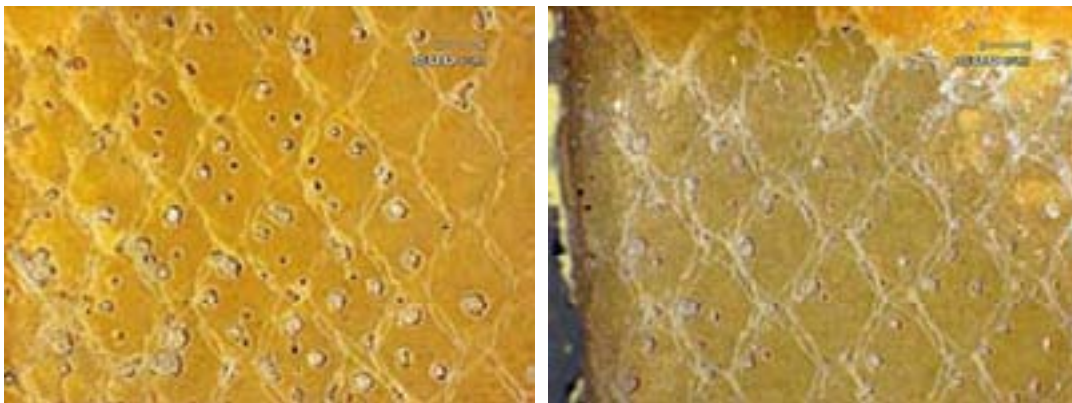
In addition to the possibility that a small region of disbond may be present from manufacture, as illustrated by the disbond discovered in blades that had not been exposed to operational loads (blades s/n 14008B and s/n 14011B), other variations in the adhesive layer near the spar end were discovered. In cases where there was extensive disbonding, numerous voids were present in the adhesive layer, see figure 34.

Figure 34: Examples of bondline voids at the end of the spar/fitting adhesive joint

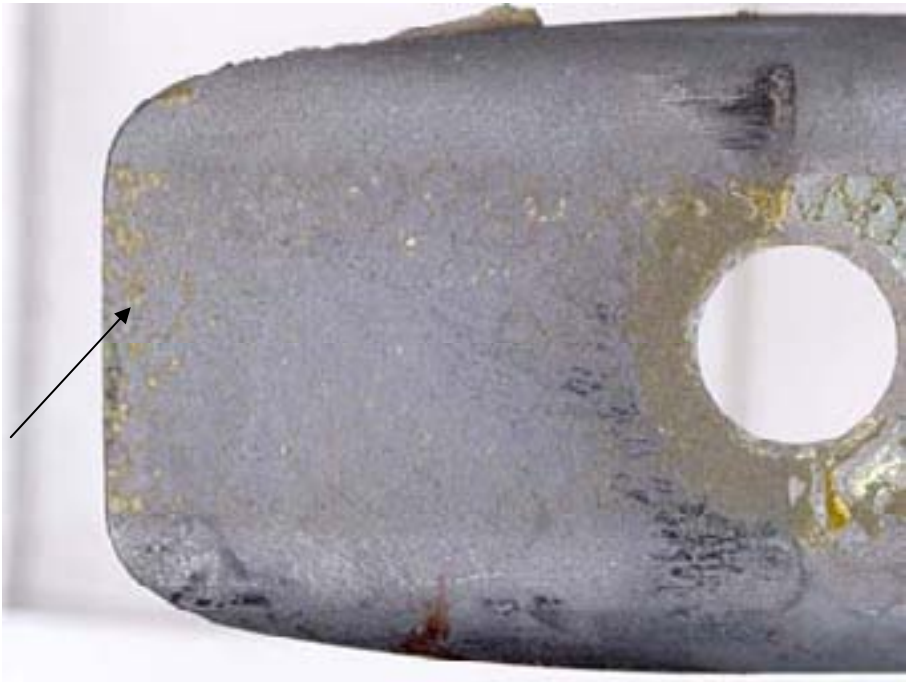
a) VH-LDR fractured blade, adhesive bonded to the spar, at the spar end is arrowed

Figure 36: The distribution of adhesive material bonded to the spar, VH-LDR

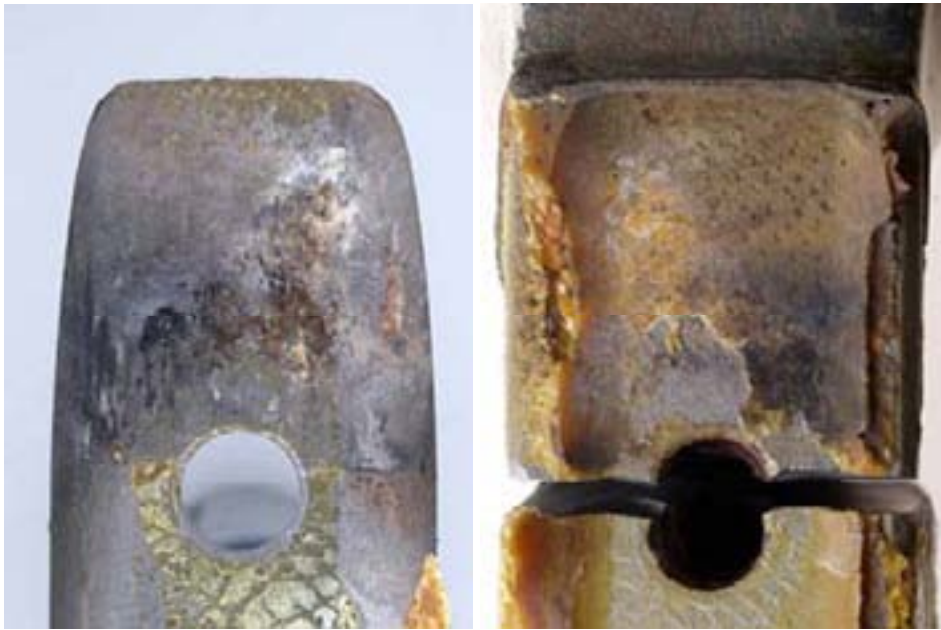
a) VH-OHA fractured blade

The evidence obtained from examinations of blade pairs, that is, the two blades fitted to a helicopter and both of which are subjected to the same operating loads and environment, shows that there is a marked difference in the extent of disbonding. In each case of fatigue cracking and blade fracture, disbonding has extended to the bolthole. While in the case of the blade paired with the fractured blade; disbonding has not extended to the edge of the inboard bolthole. This behaviour is shown in figures 41 and 42, the blade pairs from VH-OHA and VH-LDR. In contrast, blade s/n 8414B from the pair of blades fitted to VH-LOT demonstrates that bonding around the inboard hole can be protected by the installed bolt despite extensive disbonding from the end of the spar and between the two boltholes, see figure 43.

Figure 41: Extent of spar/fitting disbonding VH-OHA

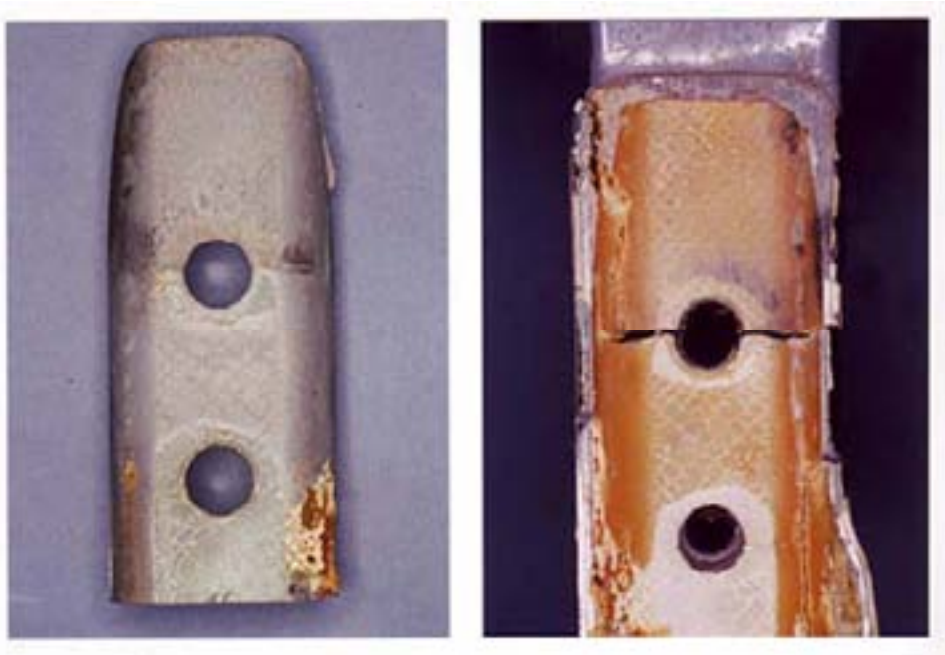
a) VH-LDR fractured blade

Figure 42: Extent of spar/fitting disbonding, VH-LDR

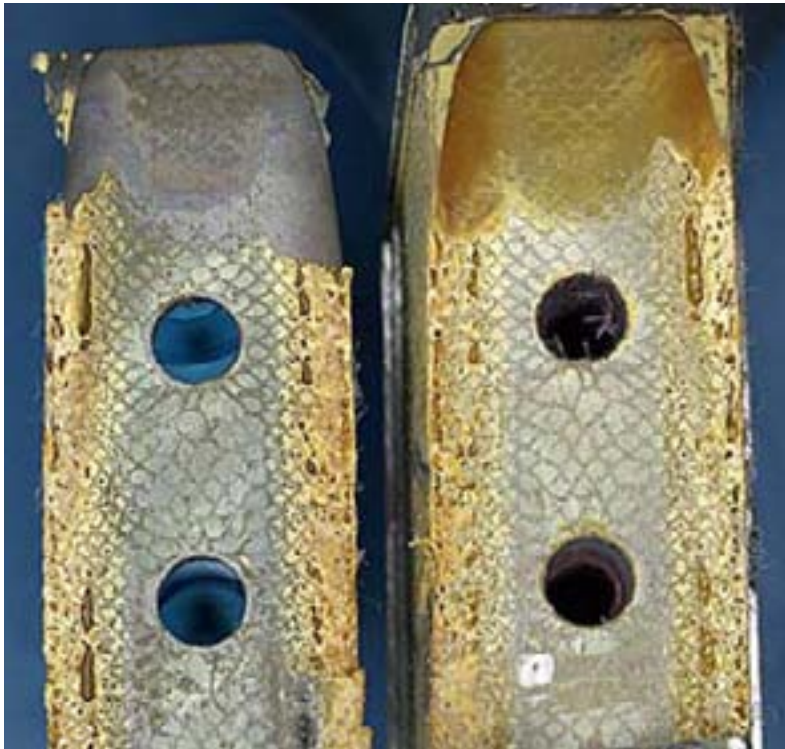
a) VH-LOT, s/n 8411B

Figure 43: Extent of spar/fitting disbonding, VH-LOT

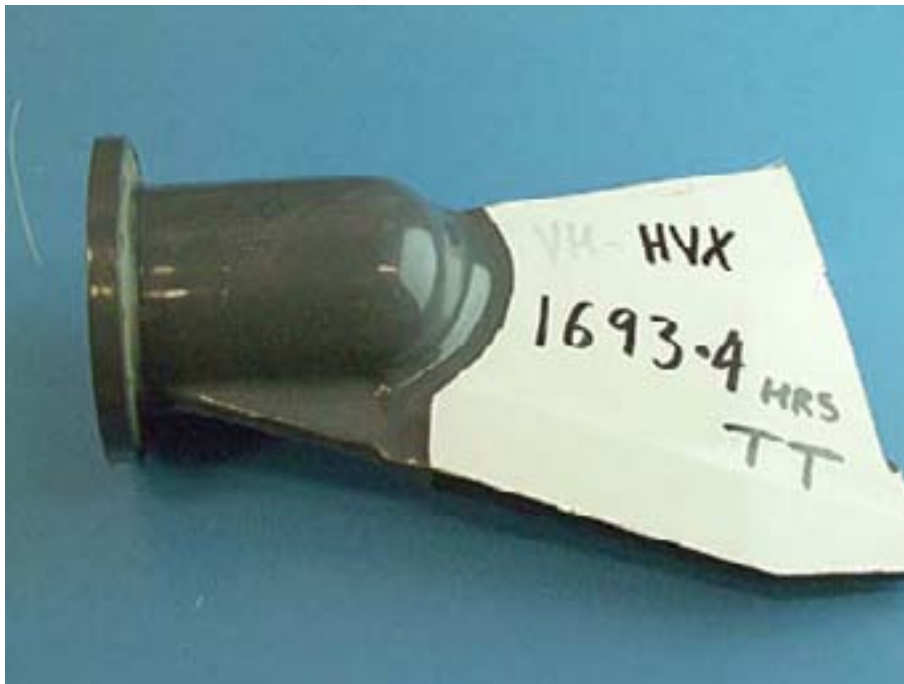
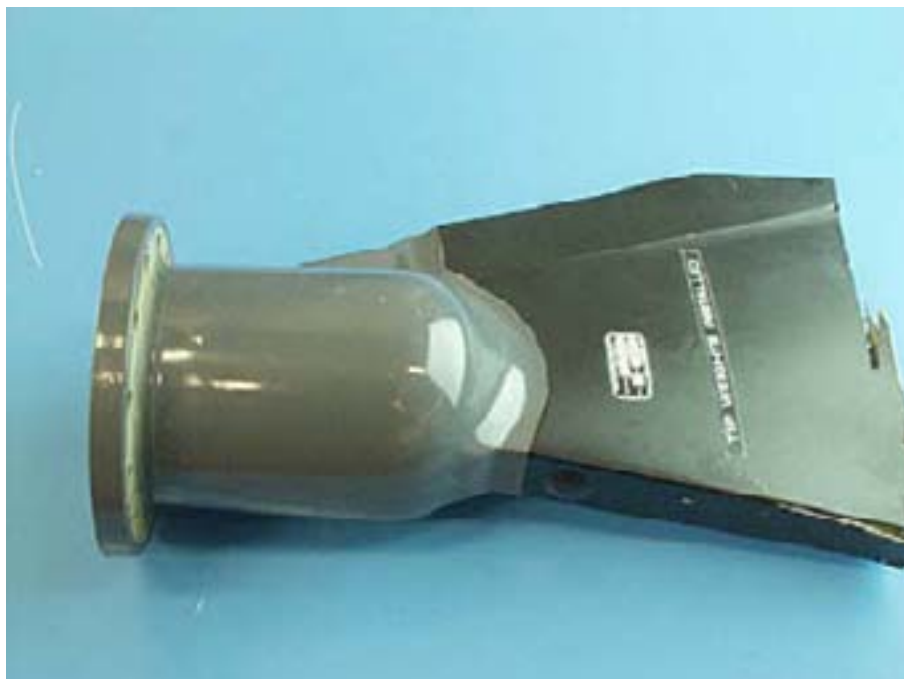
Figure 1. General condition of blade root end, upper and lower blade surfaces.

1. Photograph the blade root end fitting paying particular attention to capturing the condition of the paint on the root fitting and the presence of any cracks in the filler at the end of the lower skin and end of the spar; refer to Figures 1 and 2.

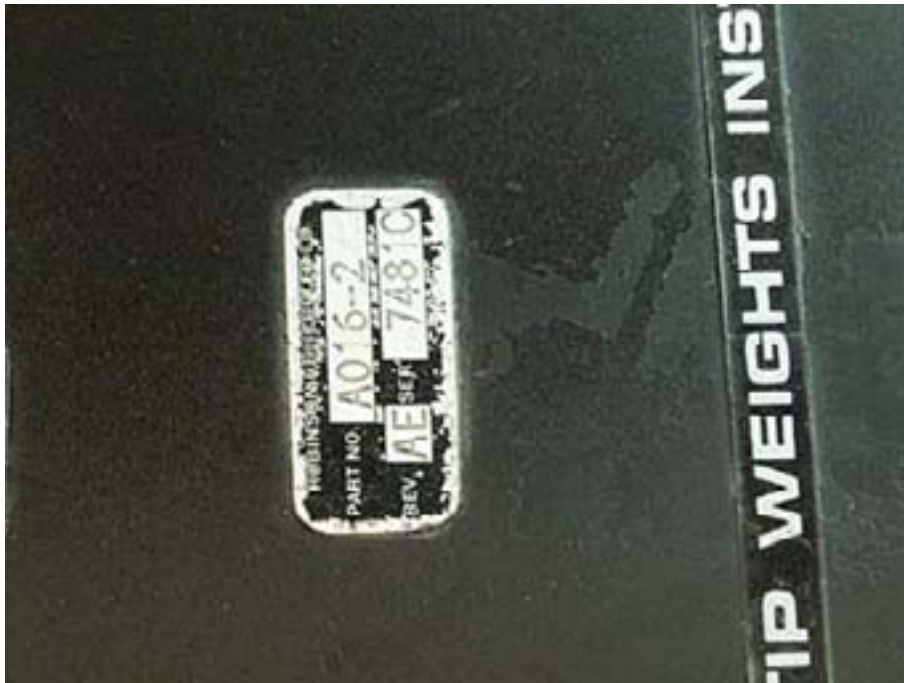
Figure 2. Serial number decal

2. Photograph the blade part number and serial number decal on the lower skin; refer to Figure 3.
3. It is evident that the progressive failure of the adhesive bonding in the spar to root fitting joint initiates at the inboard end of the blade spar (stainless steel 'D' section) and at the inboard end of the lower skin towards the leading edge of the blade. In order to assess the nature of bonding in these areas it is necessary to remove the spar from the root fitting and remove both the upper and lower skins from the root fitting without creating secondary damage to the adhesive joint in the critical areas. The following steps detail the procedure used in the Australian survey.

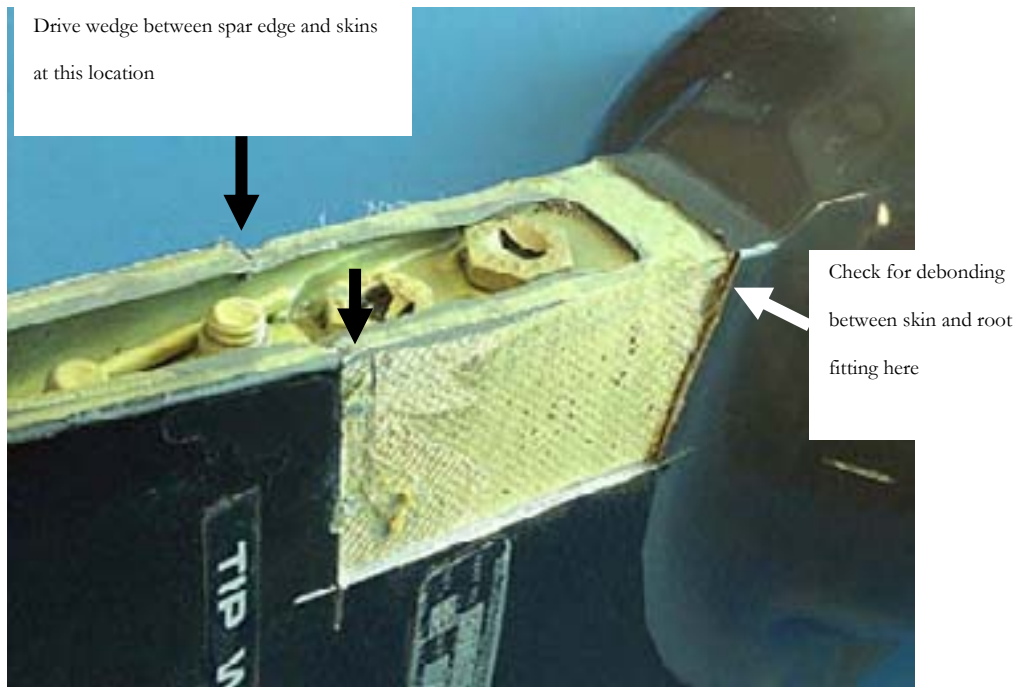
Figure 4. Blade skin removal

- Cut through the blade skins (two layers) into the root fitting. An electrically powered oscillating saw (Fein saw) was found to be most effective. Any other fine rotary saw would be appropriate; refer to Figure 4.

- The leading edge corners of the upper and lower skins are removed by applying a peel force to the outboard end of section to be removed. The peeling of the skin is achieved by driving a small wedge between the leading edge of the skin and the spar. In practice, the most effective, easily obtainable, tool for this purpose is an old screwdriver. Once the adhesive bond has been broken at the outboard end of the section to be removed a peel force is applied by applying a controlled leverage on the wedge tool. The adhesive should fail progressively from the outboard end to the critical inboard end. Take care not to drive the wedge tool into the critical areas of the adhesive joint. Note; adhesive failure from the disassembly peel forces is typically cohesive with a light yellow colouration and the exposure of the adhesive film scrim fabric. Areas of adhesive bond failure, which had occurred during the blade's service life, are of a darker colouration and smoother in nature. Typically the spar, skin or fitting surface will be exposed; refer to Figure 4.

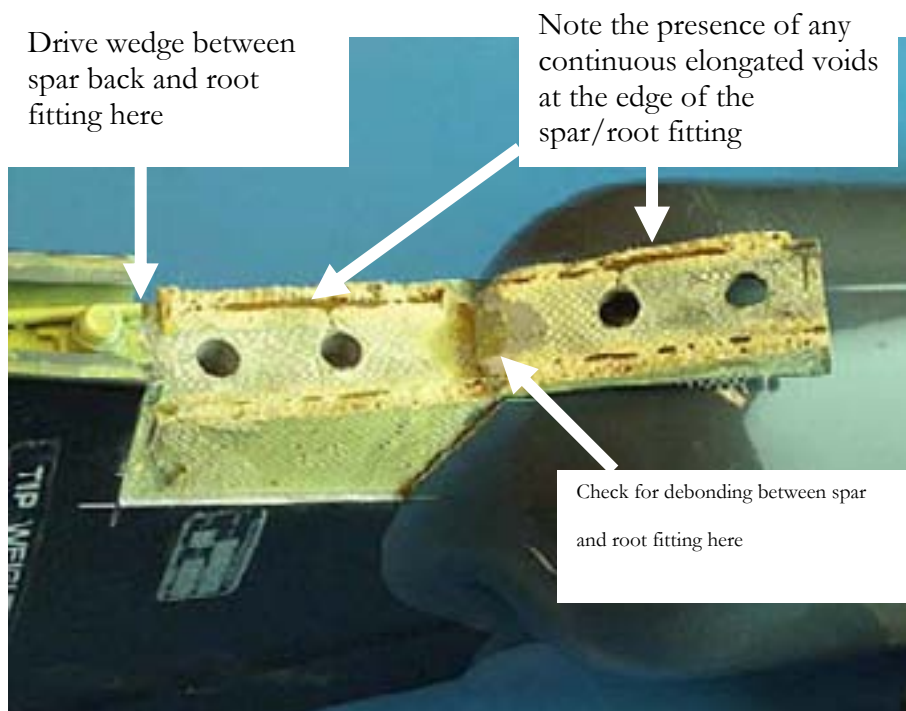
Figure 5. Blade spar removal

- The inboard end of the blade spar is removed by first removing the two bolts at this end of the spar. Cut through the spar just inboard of the third bolt. The section of spar is released by driving a fine wedge between the spar and root fitting adjacent to the cut. The peel stress created will fracture the adhesive from the cut to the inboard end of the spar. Once again the peel forces created during spar removal will result in a cohesive failure in the adhesive. Any areas of pre-existing bond breakdown can be seen in contrast; refer to Figures 5 and 6.
