CAP 747

Mandatory Requirements for Airworthiness

Issue 2 incorporating Amendments up to and including 30 September 2009

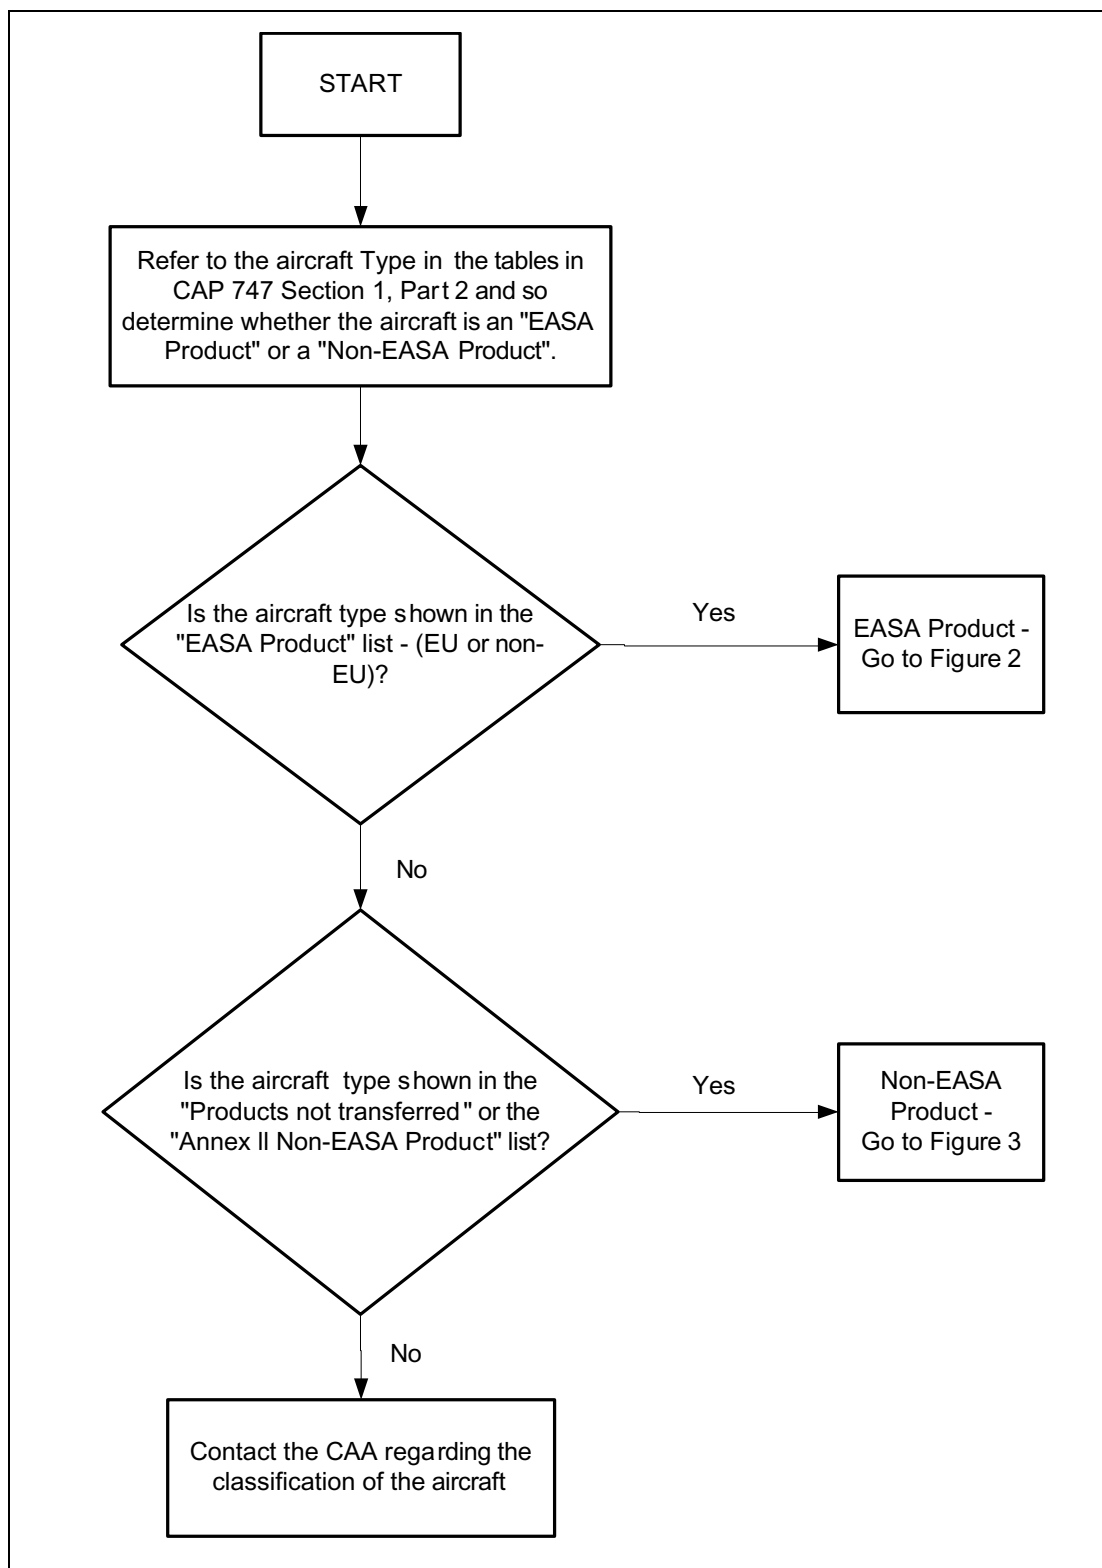
Figure 1 To identify the classification of an aircraft

In cases of doubt over the classification of a particular aircraft, clarification should be sought from the CAA.

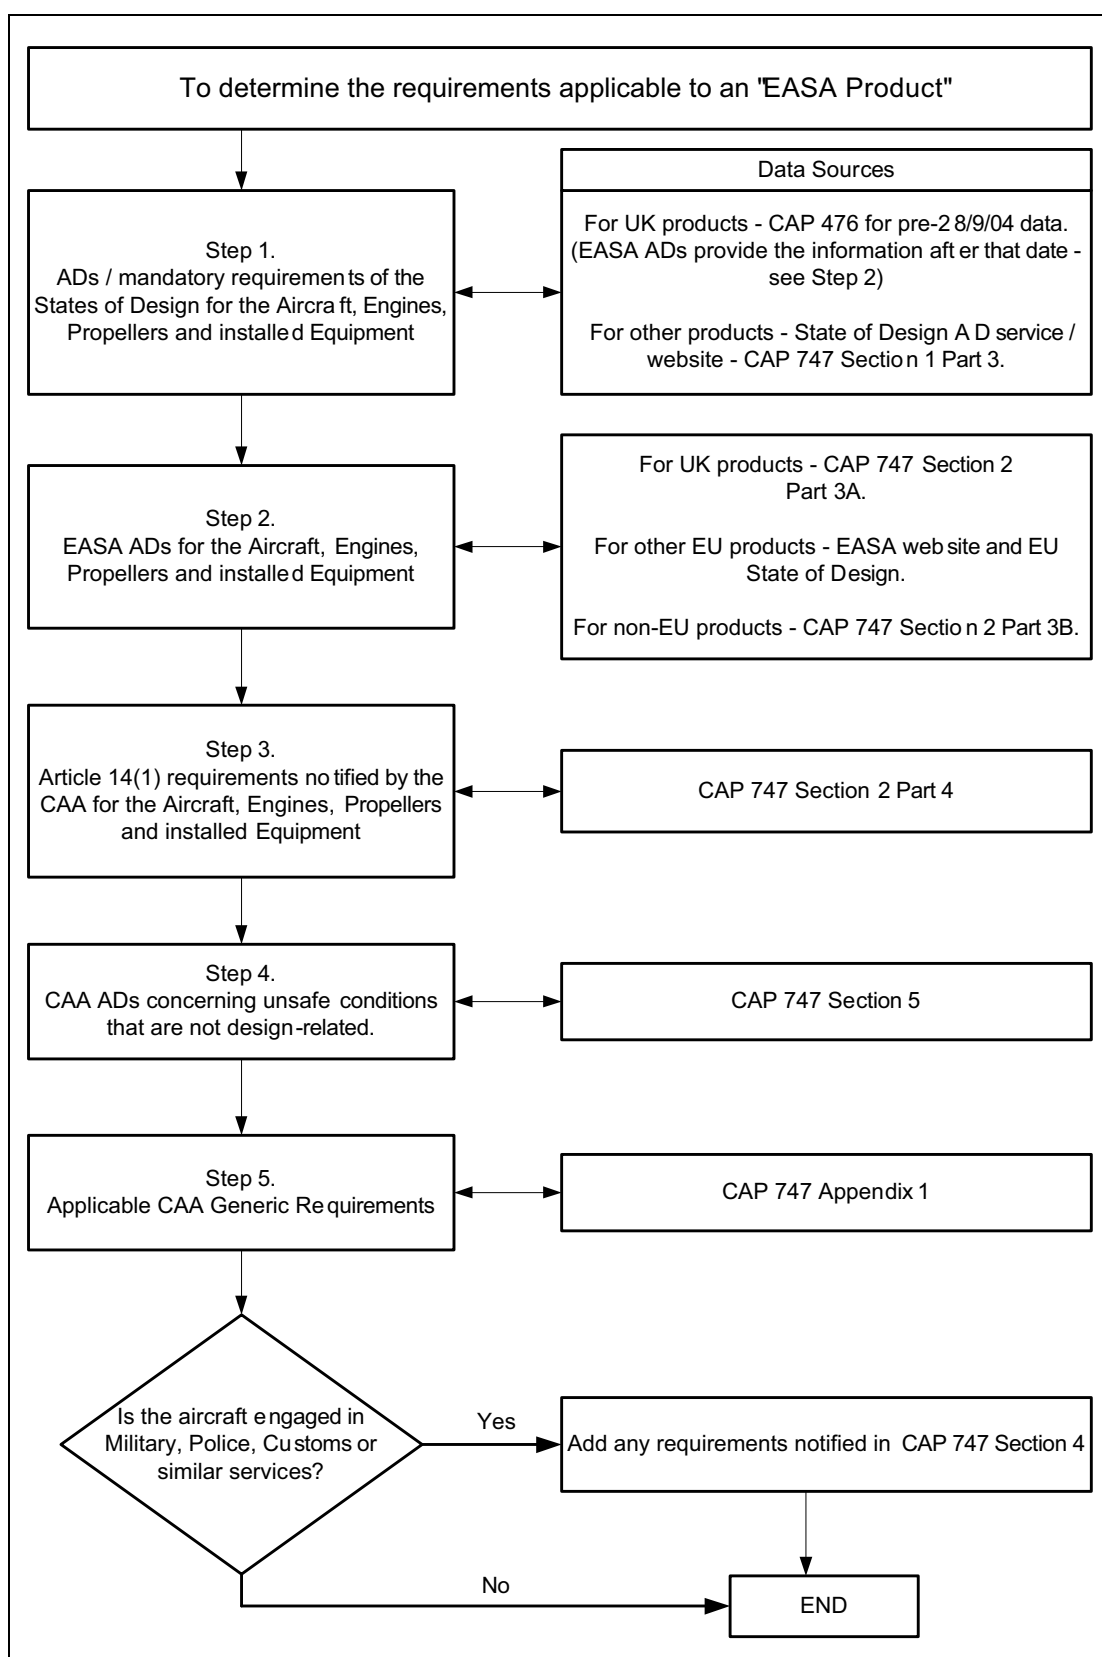
Figure 2 To identify the requirements that must be complied with by an EASA Product

The mandatory airworthiness requirements applicable to UK-registered aircraft that are subject to regulation by EASA (including engines, propellers, equipment, parts and appliances fitted to those aircraft), are defined in Section 1, Part 1, Figure 2 of this CAP 747.

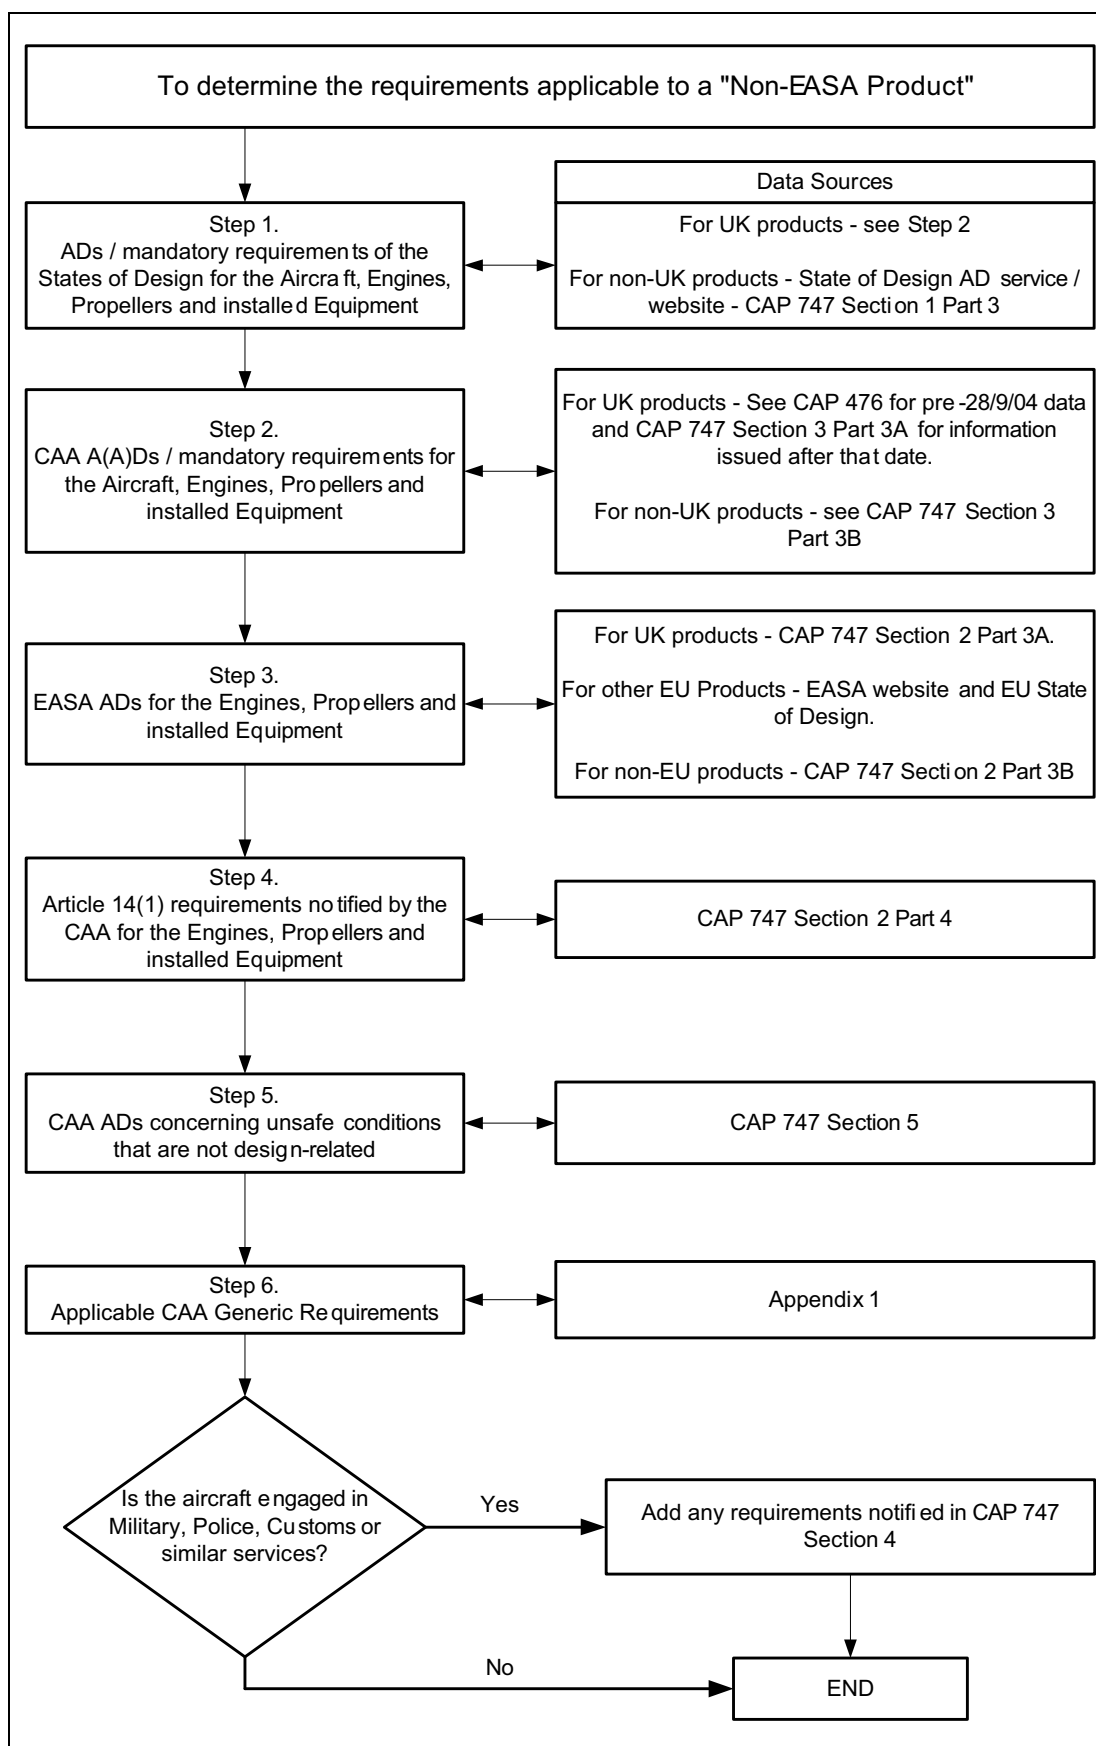
Figure 3 To identify the requirements that must be complied with by a Non-EASA Product

The mandatory airworthiness requirements applicable to UK-registered aircraft that remain subject to national regulations (including engines, propellers, equipment, parts and appliances fitted to those aircraft), are defined in Section 1, Part 1, Figure 3 of this CAP 747.

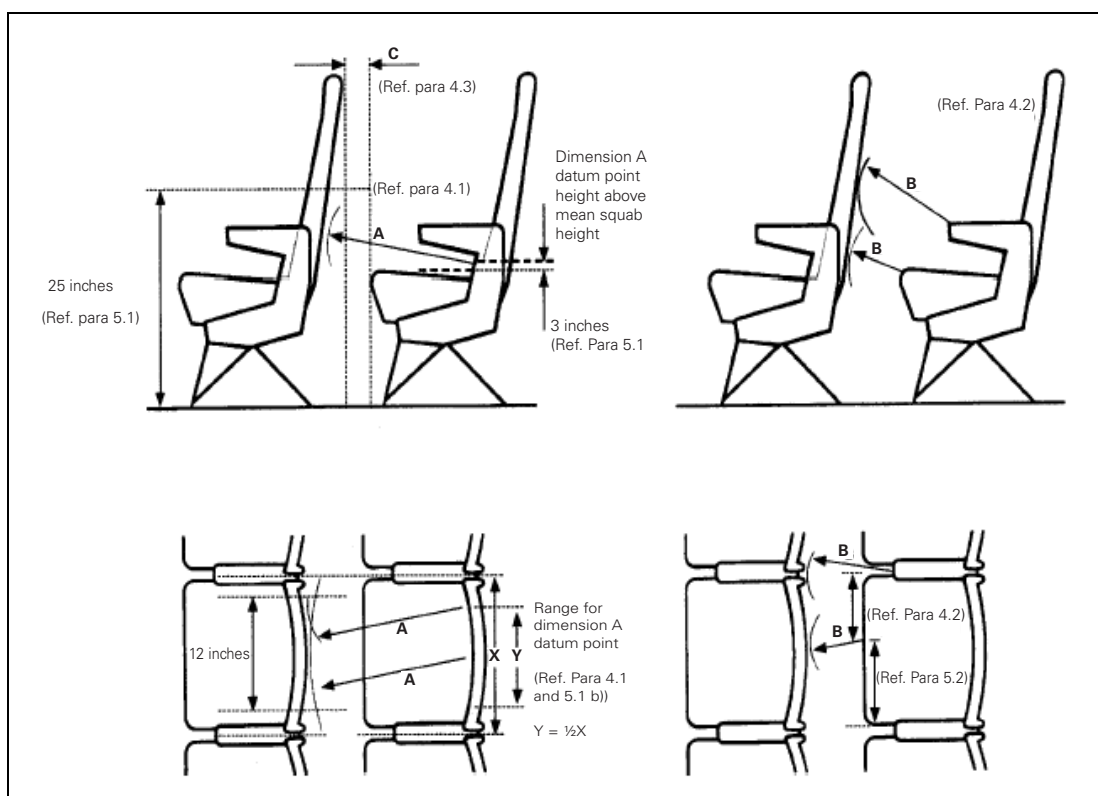
- 4.1 The minimum distance between the back support cushion of a seat and the back of the seat or other fixed structure in front, shall be 26 inches. (Figure 1, Dimension A.)
- 4.2 The minimum distance between a seat and the seat or other fixed structure in front, shall be 7 inches. (Figure 1, Dimension B.)
- 4.3 The minimum vertically projected distance between seat rows or between a seat and any fixed structure forward of the seat, shall be 3 inches. (Figure 1, Dimension C.)

Figure 1 Minimum Dimensions required by paragraphs 4.1, 4.2 and 4.3

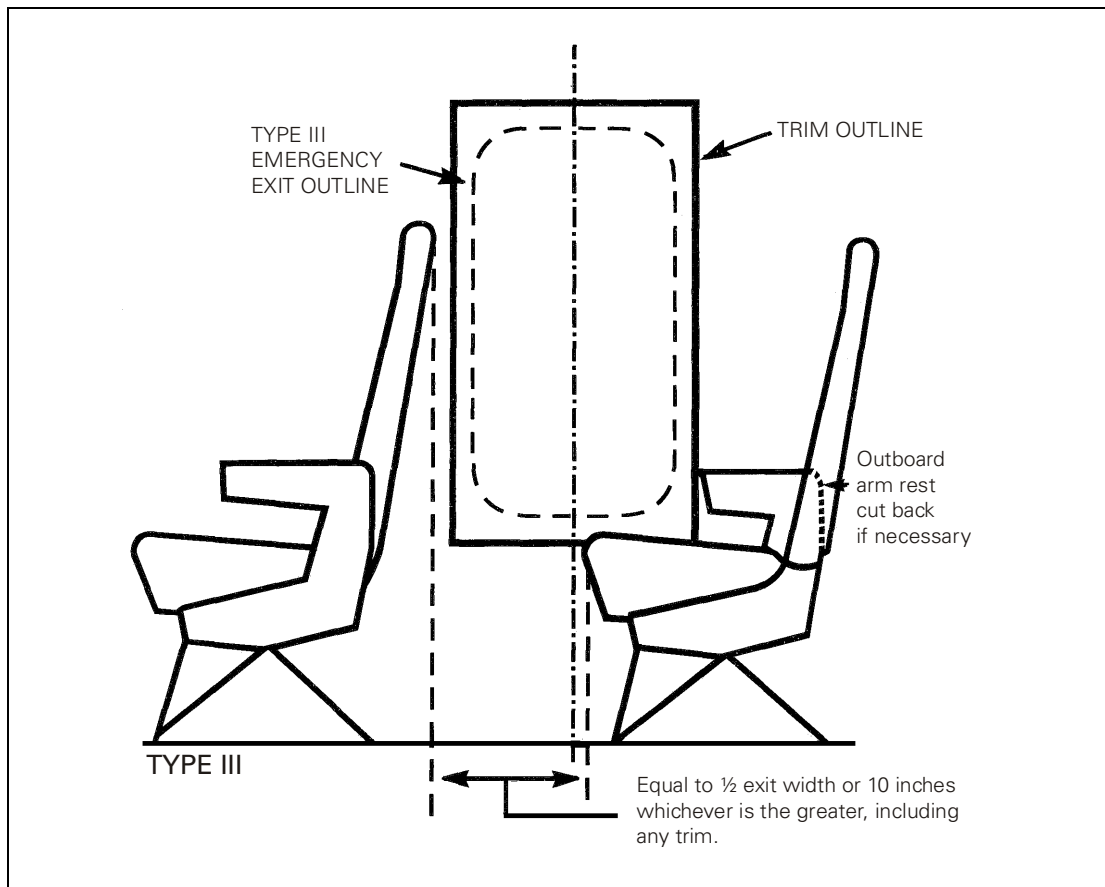
Figure 1 Minimum Access Space Required by Paragraph 4.1.1

- NOTE:** The outboard armrest must not protrude across the exit aperture nor impede the removal of the exit hatch.
- 4.1.2 Seats may only be located beyond the centre line of a Type III exit provided there is a space immediately adjacent to the exit which projects inboard from the exit a distance no less than the width of a passenger seat and the seats are so arranged as to provide two access routes between seat rows from the cabin aisle to the exit.

NOTE: Where more than one access route from the cabin aisle to a Type III exit is provided, the minimum access width referred to in paragraph 4.1.1 need not apply (see paragraph 5.4 of this Requirement).

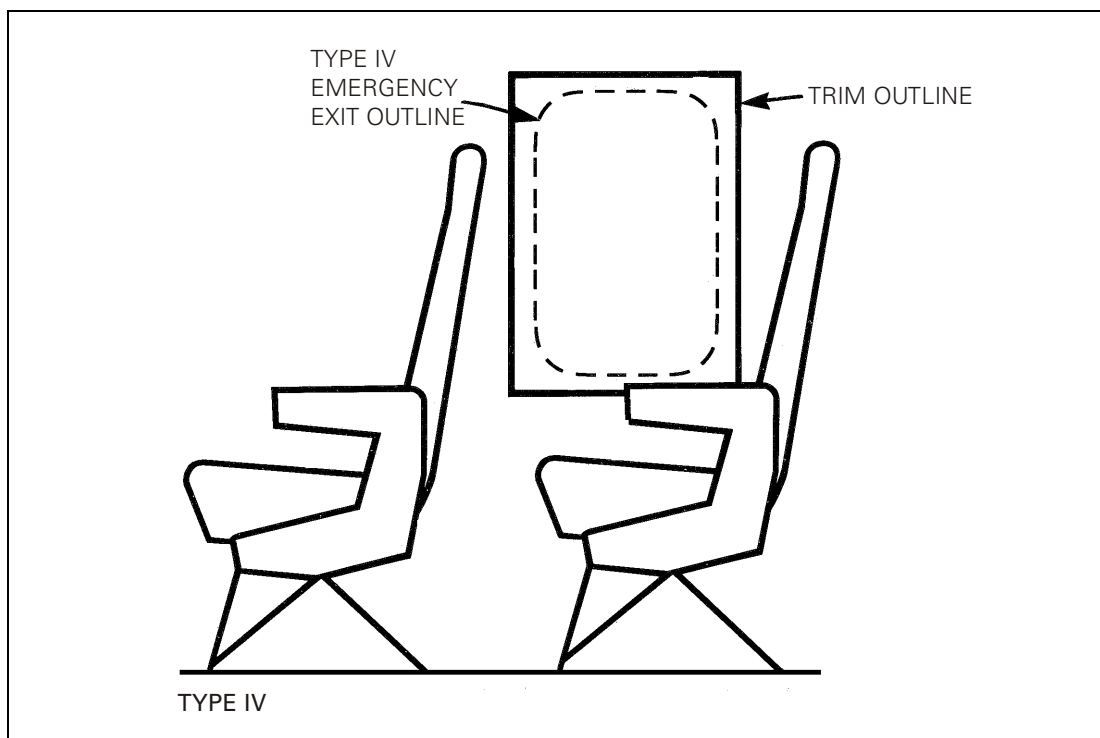
Figure 2 Minimum Access Required by Paragraph 4.1.3

- 4.1.3 Where all forward facing or all aft facing seats are arranged such that there is a single access route from the aisle to a Type IV emergency exit, then the projected exit aperture shall not be obstructed from the exit to the aisle (see Figure 2 and paragraph 5.4 of this Requirement).

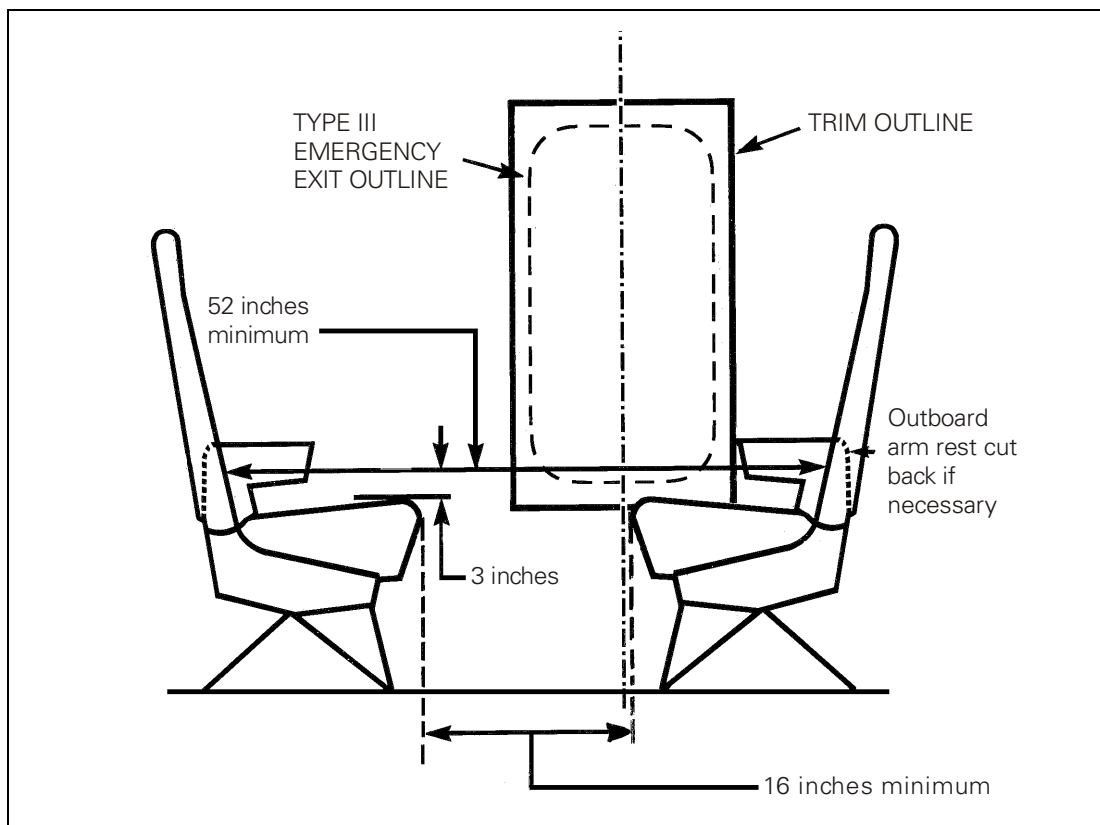
Figure 3 Minimum Access Required by Paragraph 4.1.5

- 4.1.4 Seats may only be located in line with a Type IV exit such that the seat back is within the projected exit aperture provided there is a space immediately adjacent to the exit. Such a space shall project inboard from the exit a distance no less than the width of a passenger seat and be so arranged as to provide two access routes between seat rows from the cabin aisle to the exit. (See paragraph 5.4 of this Requirement.)
- 4.1.5 Where face-to-face seating is provided adjacent to the emergency exit, the minimum permitted distance between any parts of the seat rows shall be 16 inches vertically projected and the minimum permitted distance between the plane of the seat backs on either side of the access route shall be 52 inches measured on the mid-lines of each seat place at a height of 3 inches above the seat cushions. (See Figure 3 and paragraph 5.6 of this Requirement.)
